PPS PLUMBING REPORT

CUSTOMER NAME	Bay Building
DATE AND TIME ONSITE	9 Dec 2021 07:30 AEDT
PROPERTY ADDRESS	16 Aaran Close, Endeavour Hills
CLAIM NUMBER	SBAR-ALLI-1670192
HOMEOWNERS NAME	James
REPORTED ISSUE	Cracking to rendering at North-West corner of dwelling.
PREPARED BY	PROJECT PLUS SERVICES

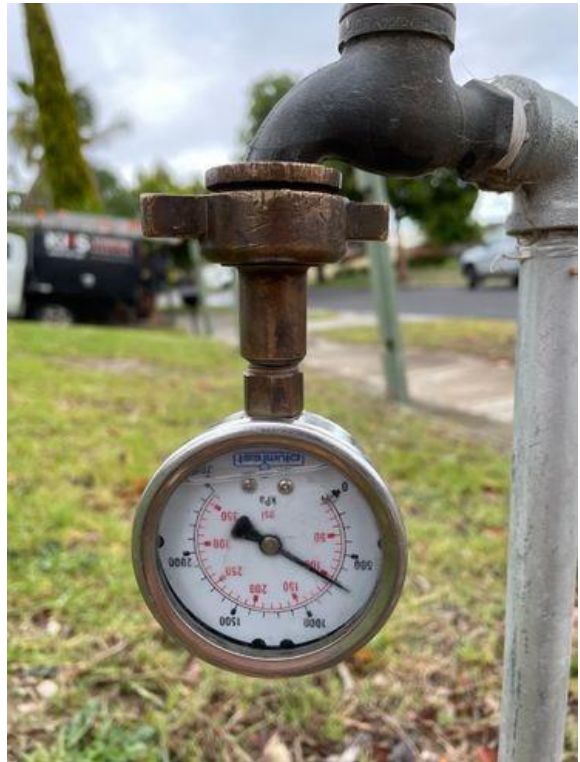
The regulations require that provision be made to ensure that the maximum static pressure at any outlet (other than a fire service outlet) including heated water within a building not exceed 500kPa. We recommend that a pressure limiting valve be installed on the front water meter.

700kPa

MAIN LINE WATER PRESSURE

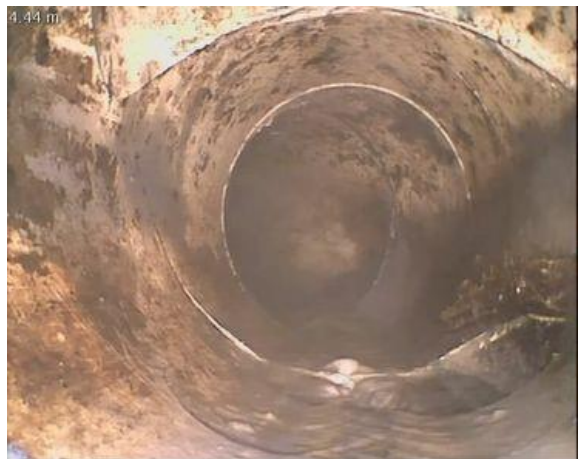
CCTV OF DRAIN

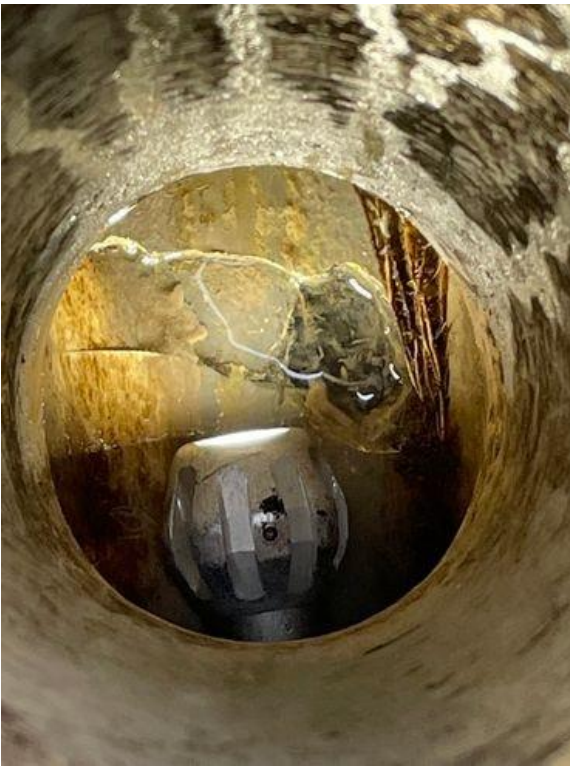
Following our on-site inspection, we believe the ground movement issue at this property is most likely related to the stormwater drain which was completely blocked by tree roots causing water to continually seep out.

TREE ROOT IN DRAIN

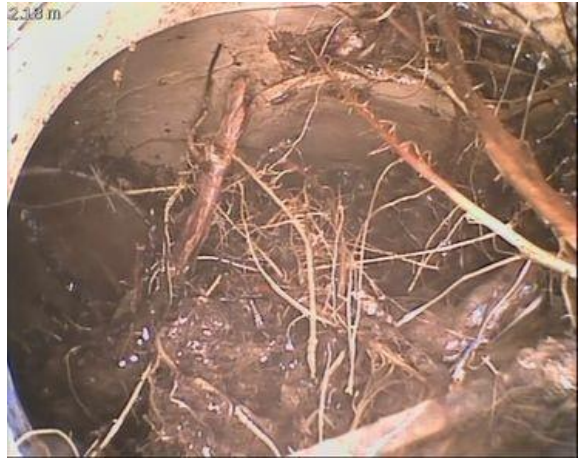
TREE ROOT IN DRAIN

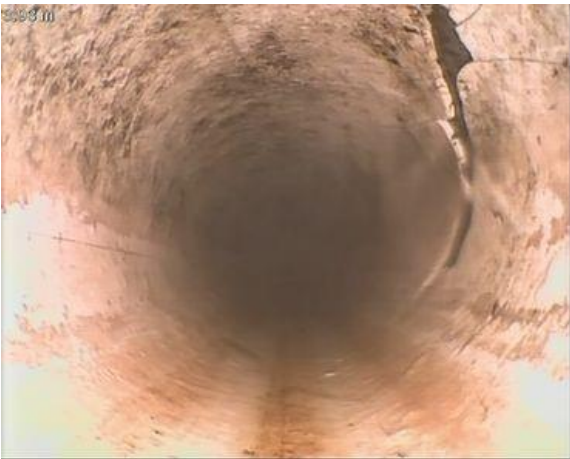
BROKEN PIPE

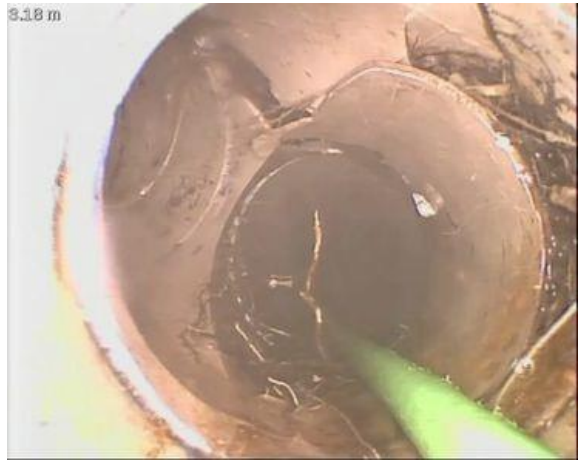
BROKEN PIPE - TREE ROOT

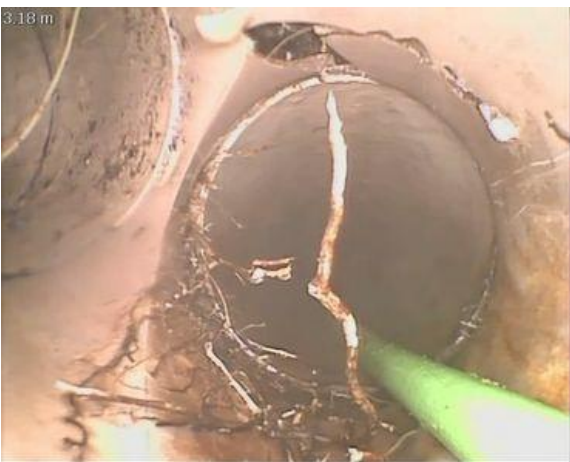
BROKEN PIPE

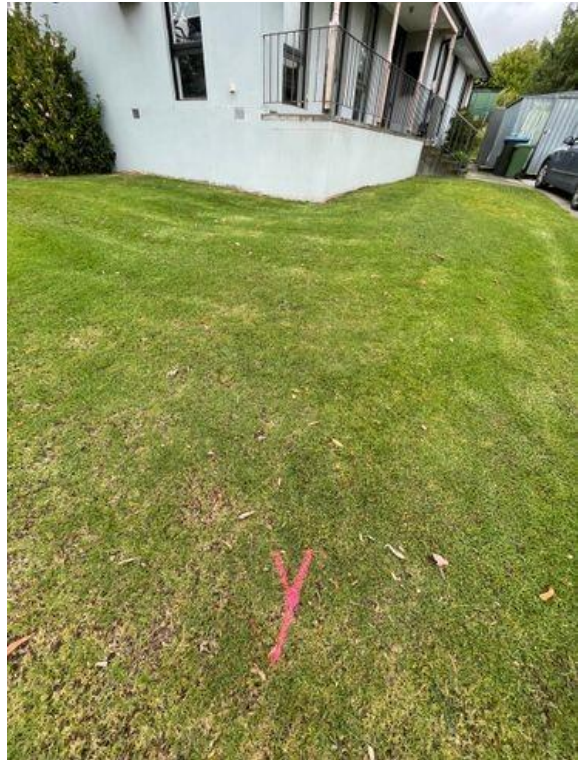
DIG AND REPAIR STORMWATER AT THIS POINT

- Insufficient stormwater drainage at NE corner of property. Stormwater pools at lowest point, which would seep into NW corner due to slope of land.
- Pit and pump should be installed to correctly drain water.
- Dig and repair of sections of stormwater which have been marked out on front lawn.
- Dig and repair of crack in sewage at front of property.
