Roof Report

Property Address	16 Aaran Close Endeavour Hills VIC 3802
Brand	Allianz Australia Insurance Limited
Claim No.	6210287371

Builder	Ambrose Construct Group Pty Ltd
Ambrose Job - PO No.	20067240

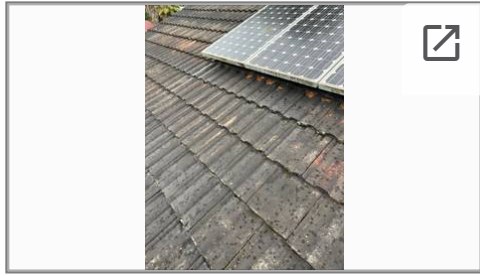
Roof sheeting images (with matching colour swatch if applicable):

Roof Type:	Gable
Roof Material:	Concrete Roof Tile
Roof sheeting colour:	Faded charcoal
Can the roof sheeting colour be matched?:	<input type="checkbox"/> Yes <input checked="" type="checkbox"/> No

Roof Pitch: 18.3° (under pitched)

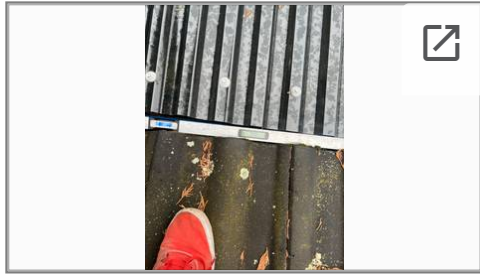
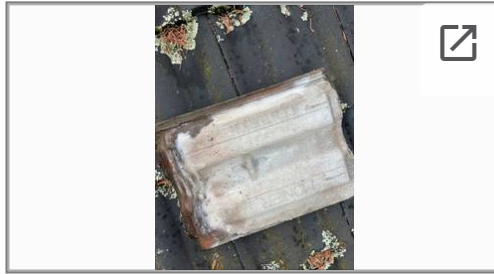
Insert BLRT/ descriptive pic clearly outlining the causation and point of entry:

The team identified the gutter does not have fall, debris in the gutter and the team identified that the roof is under pitched at 18.3° and there is no sarking

With the evidence provided at the time of the assessment the team identified that the back of the tiles have water stains all on them as there is no sarking and the roof is under pitched, gutter has no fall and has debris built up in them there are no weep holes in the mortar of the top ridge

Roof tiler scope:
Full re roof

Roof plumber scope:
-replace gutters
