FORENSIC ENGINEERING REPORT

CAUSATION REPORT & SOW

Scope: Distressed Dwelling Assessment

Address: 16 Aaran Close, Endeavour Hills VIC 3802

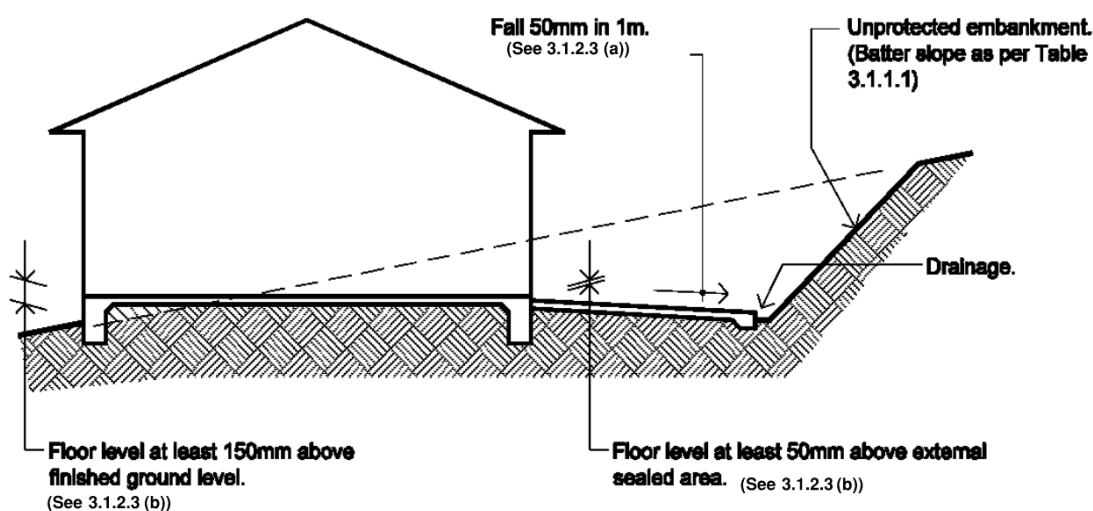
According to the Building Code of Australia—3.1.3.3 regarding surface water drainage, the following applies. First, the external finished surface surrounding the slab must be drained to move surface water away from the building and graded to give a slope of not less than 50 mm over the first 1m from the building (see Figure below).

In this instance upon inspection of the property it was noted that the site drainage around the premises was generally inadequate, allowing surface runoff to flow into the subfloor during rainfall. Notably, the patio paving slopes towards the dwelling, and issues with the patio strip drain was incorrectly installed and undersized. Moreover, the outlet pipe was not positioned at the lowest point of the strip drain. External surfaces adjacent to the dwelling, including permeable materials like paving or garden areas, also allow moisture ingress into the foundational soil, posing a potential risk for foundation problems.

- Engaged a qualified plumber to conduct a CCTV survey and inspect the stormwater system to check for any blockages and repair as required.
- Upgrade the patio strip drain & pavement generally to ensure adequacy, This should be designed by a qualified civil engineer. It is likely that the strip drain requires upgrade, and the patio paving requires relaying to improve grade. All subject to civil engineer design.

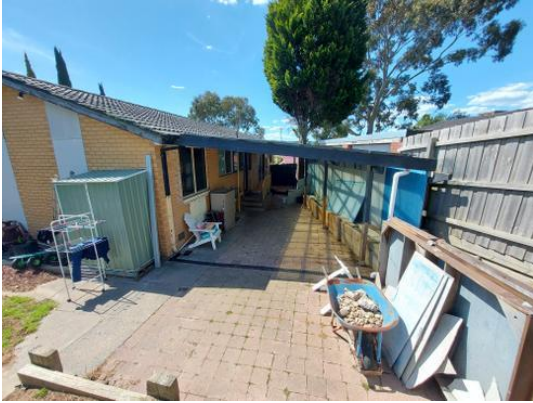
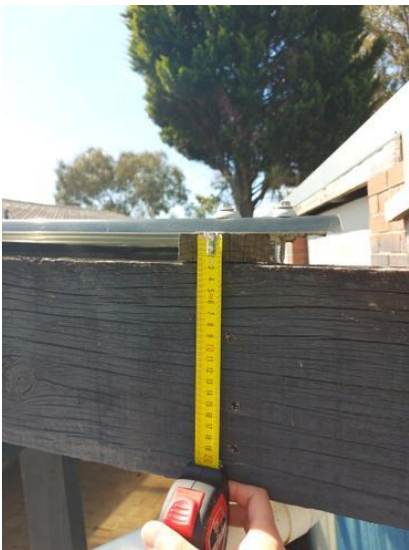
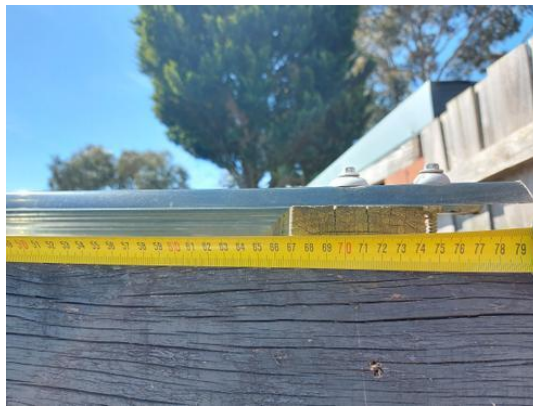
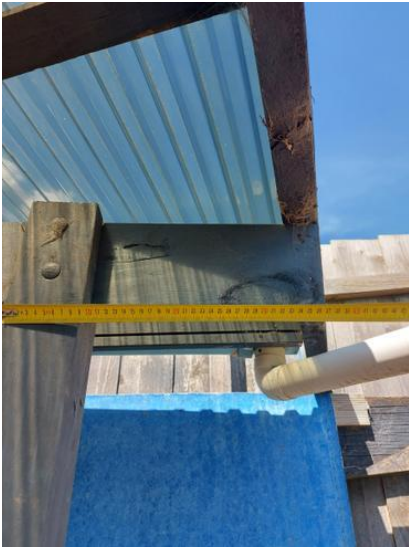
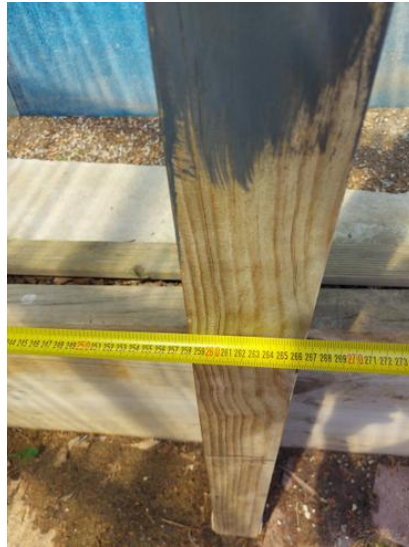
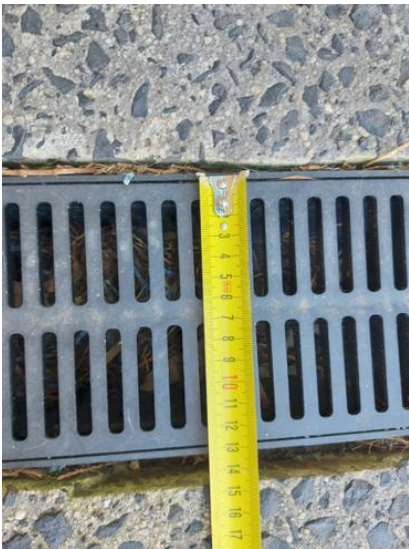
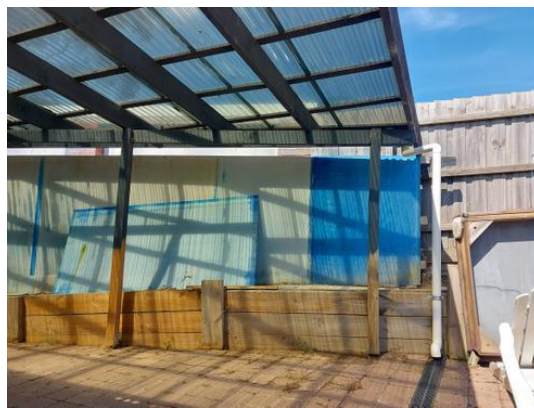
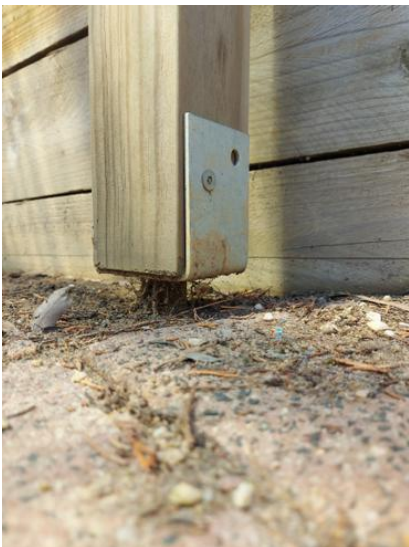
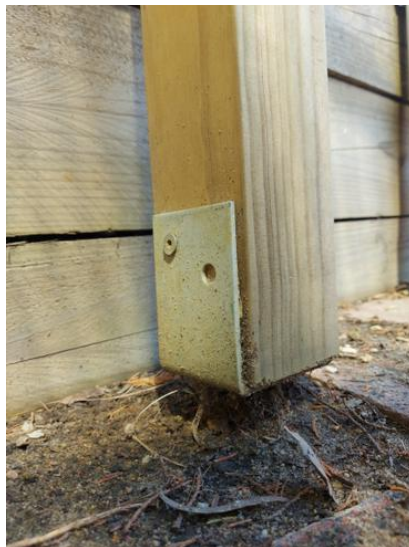
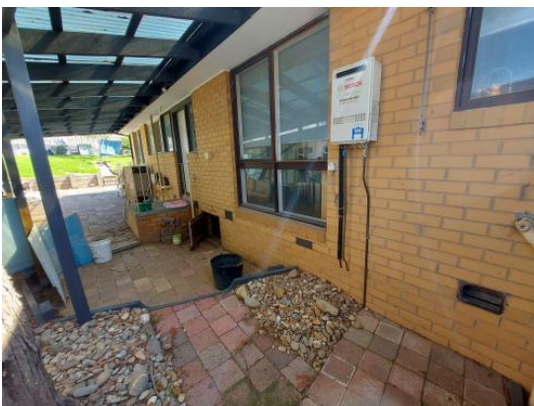
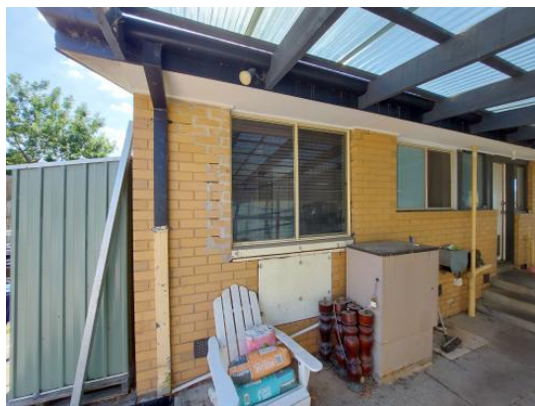
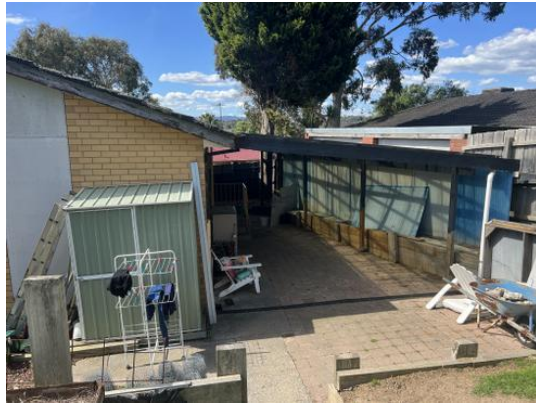
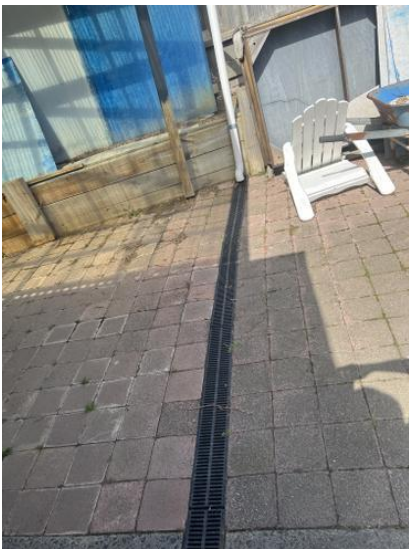
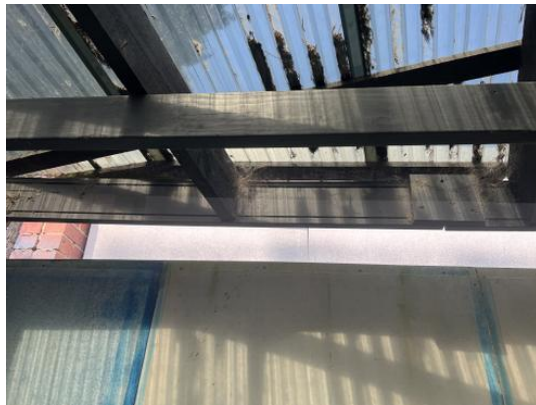
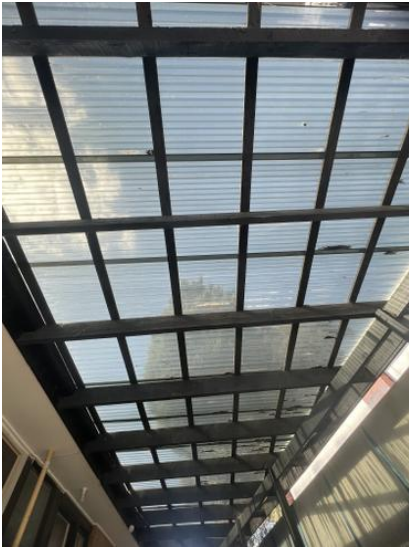
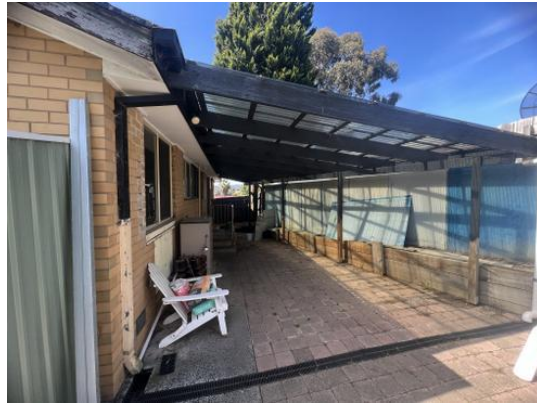
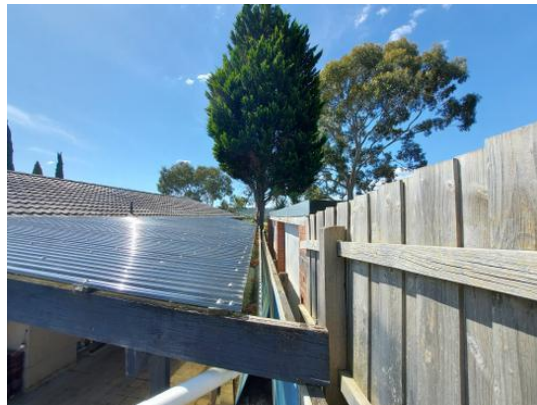
- Paving was uneven and sloped towards the dwelling, which promotes water flow into subfloor area (approx. 2° fall).
- Patio posts were slightly out of plumb.
- Patio posts fixed to stirrup without adequate roof/knee bracing.
- Splitting observed in the roof battens.
- Roof battens (70x25) were determined to be undersized.
- Roof sheeting inadequately secured to battens, with screws exposed in the air.
- Non-compliant splice connections identified in the perimeter beam.
- Strip drain was not installed correctly and was undersized.
- The outlet pipe was not located at the lowest point of the strip drain.

The patio exhibits a general lack of workmanship. Although the timber posts are generally in good condition, there are deficiencies in the installation, such as the use of stirrups to support each post on the footing but without adequate roof/knee bracing. This oversight could be contributing to the slight misalignment of the posts, as they lack the necessary resistance to lateral loads.

Further evidence of subpar workmanship is found in the patio roof structure, including the poor splice connections in the perimeter beam, undersized and splitting roof battens, and improperly secured roof sheeting where some screws do not penetrate the battens at all. Moreover, the patio gutters lack adequate fall.

- Demolish and reconstruct the entire patio to standard, ensuring proper flashing at the dwelling attachment interface, and incorporating adequate roof and gutter fall. Timber posts can be retained, subject to confirmation that the existing footings are adequate. The new verandah will need to be designed by qualified structural engineer as part of building permit process.
- Obtain Soil report to confirm the size of the existing footings is adequate for hold down purposes and the footing founding depth is adequate.

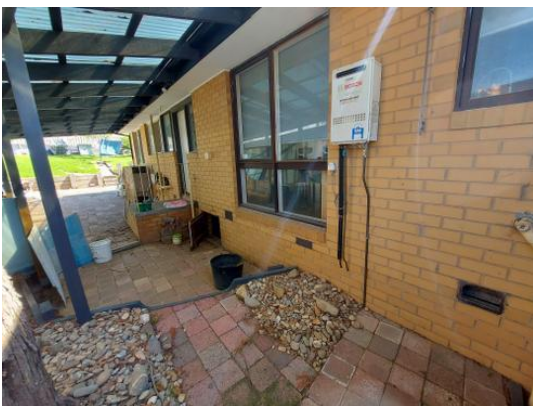
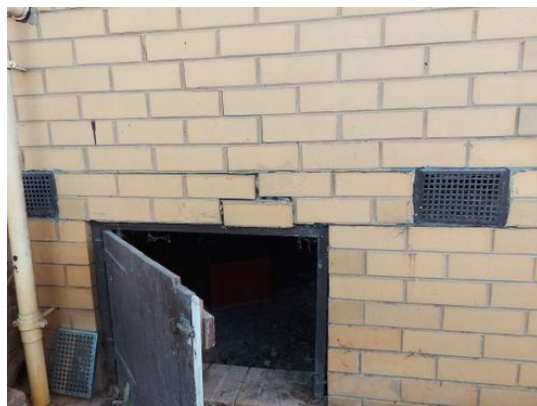
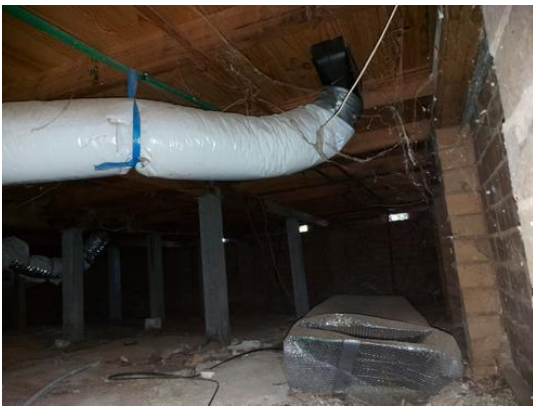
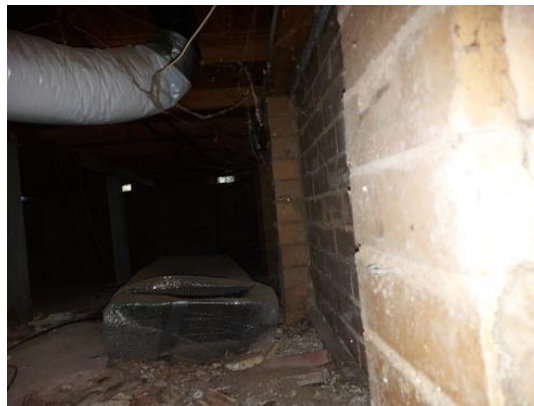
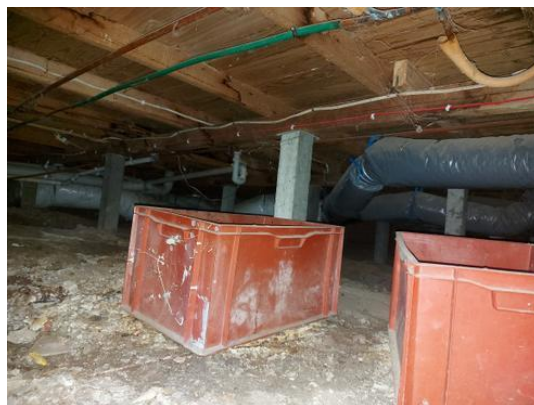
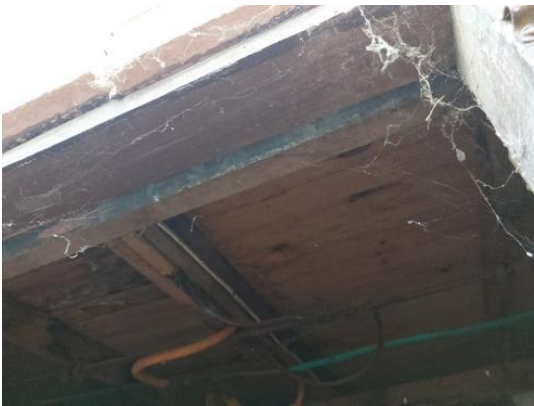
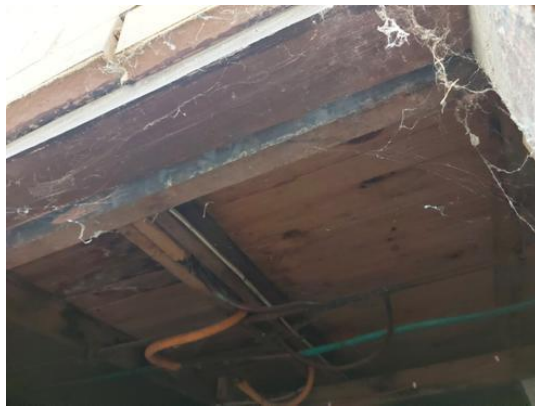
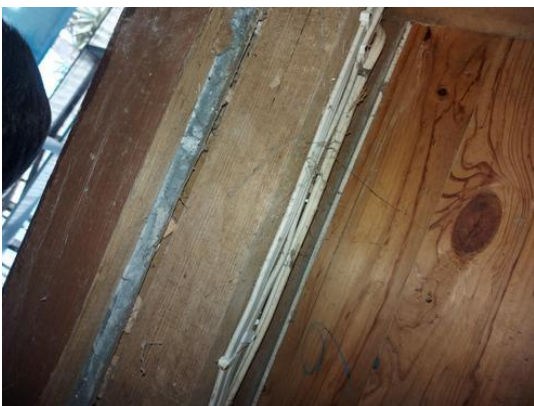
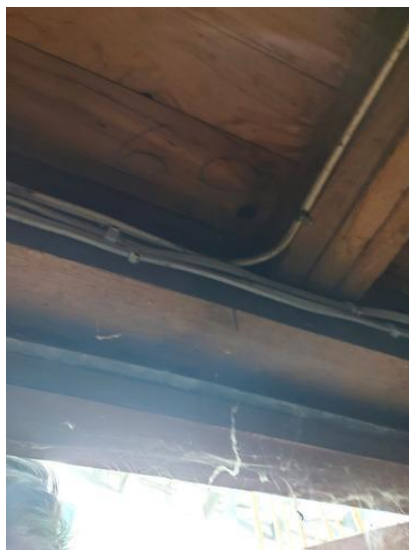
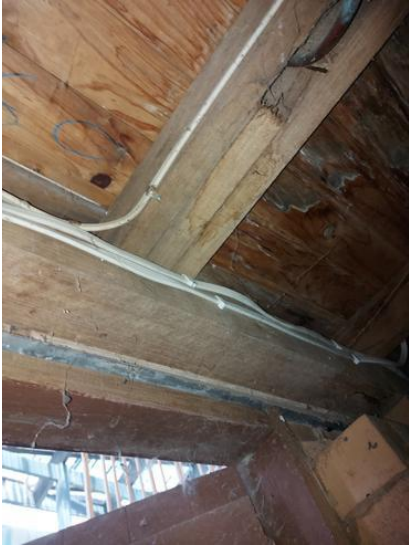
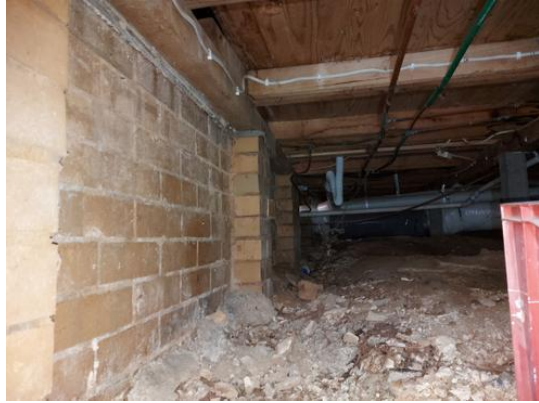
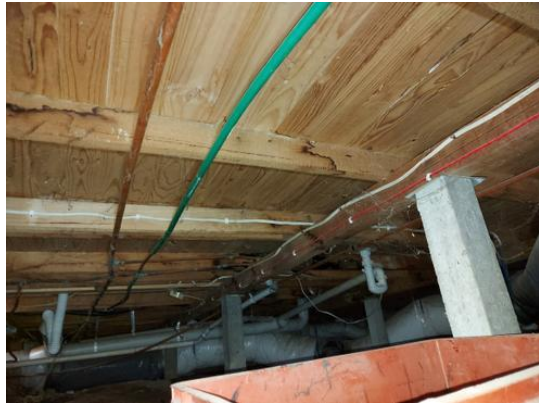
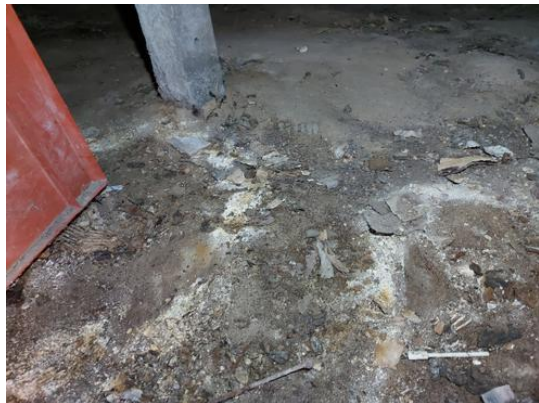
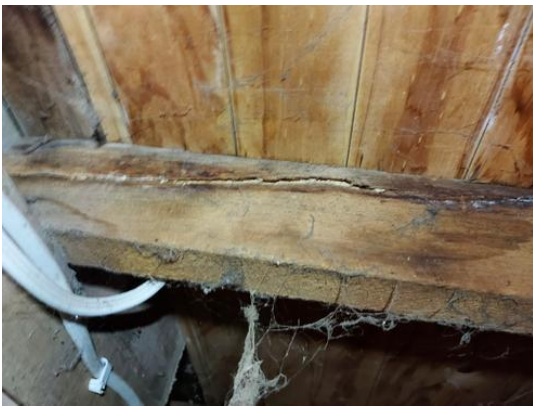
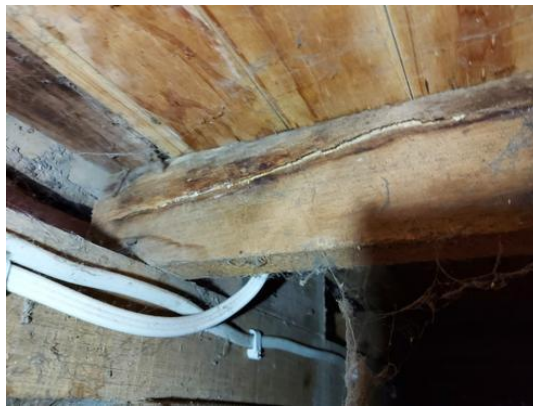
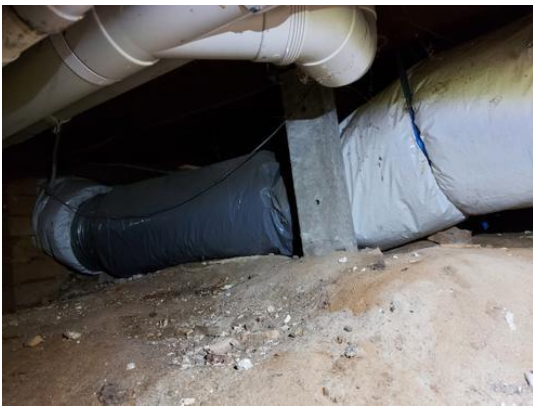
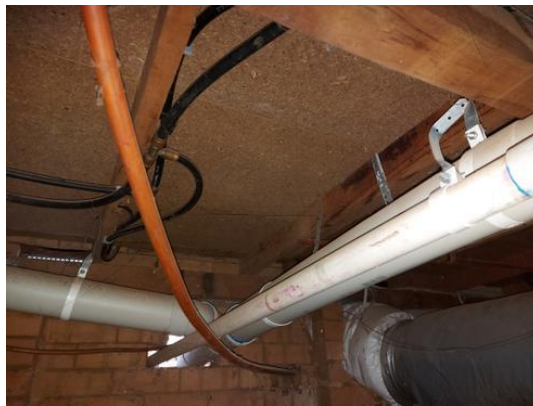
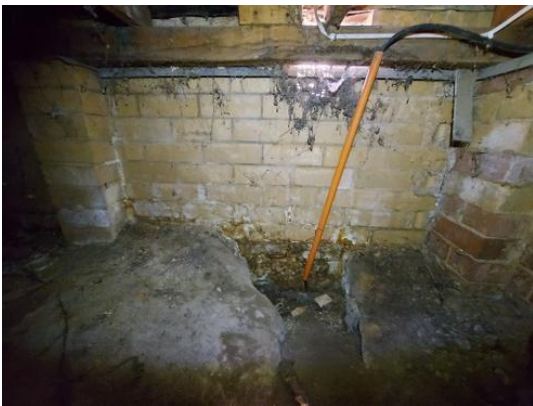
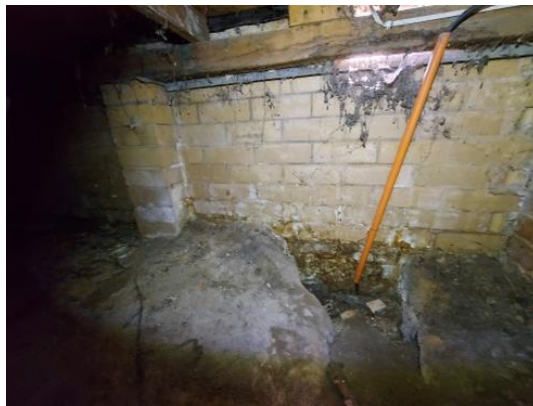
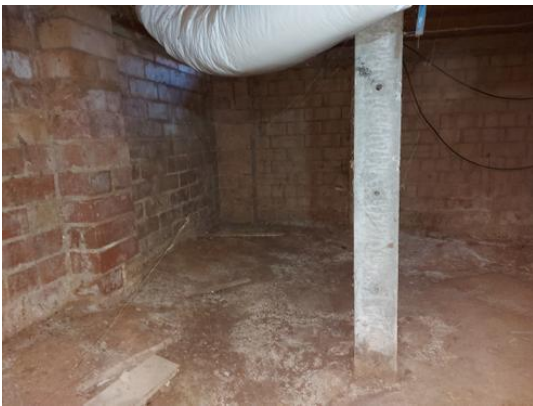
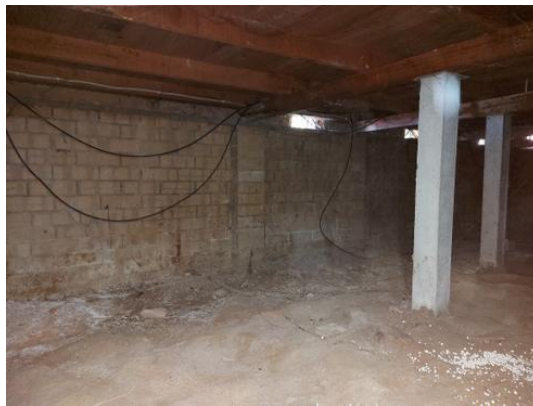
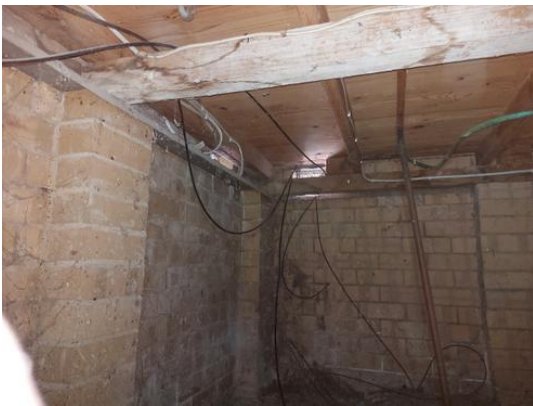
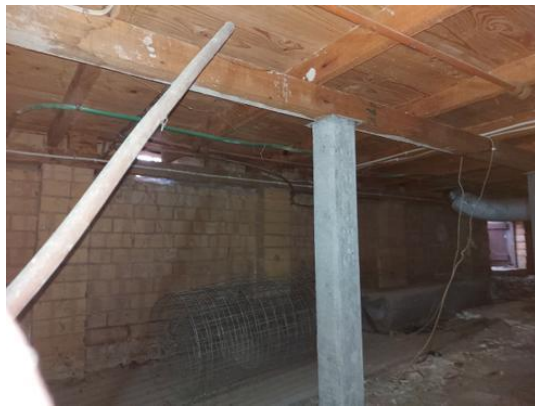
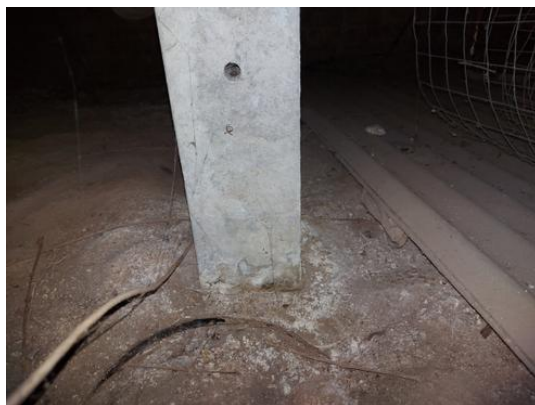
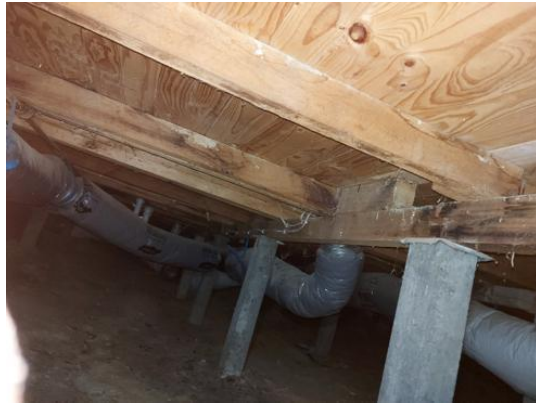
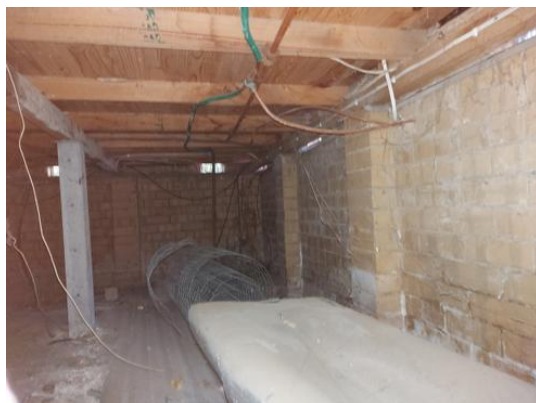
- Water stains present on multiple timber subfloor members.
- Several joists under the laundry/bathroom area showing signs of rot.
- Section of bearer under the bathroom/laundry area showing signs of rot.
- The concentration of observed rot near the laundry/bathroom area, coupled with the significant clearance from the ground, suggests the presence of a leakage issue.
- A hole has been excavated near the southwestern corner of the subfloor and requires backfilling. It is not clear as to the purpose of this hole (possibly for service installation). Additionally, it seems that the footings have been partially demolished in this area.
- The subfloor consistently showed overall dampness during the inspection, attributed to runoff from the patio and leakage.

Regardless of this, signs of rot were identified in several joists and bearers near the Laundry/Bathroom area. Given the elevated clearance from the ground and the concentration of rot in this area, VCE suspects a leakage issue within the bathroom rather than damage from the previous storms or runoff from the patio. A plumbing report is recommended to gain a comprehensive understanding of the leakage source and enable repairs. With respect to the sub-floor damage, linings will need to be removed to enable a thorough inspection of the wall and floor framing and to determine optimal reinstatement solution. Given the damaged elements are likely to be structural, a building permit will most likely be required before reinstatement to this area can occur.

- Engage a qualified plumber to check for any leakage near the bathroom area.
- Conduct a thorough inspection of the roof (plumbing report) to confirm any leakage or water damage.
- Engage a qualified structural engineer to design the rectification work for the rotten subfloor and any identified water damage in the roof space. This is likely to require building permit (subject to advice from building surveyor and findings from inspections).

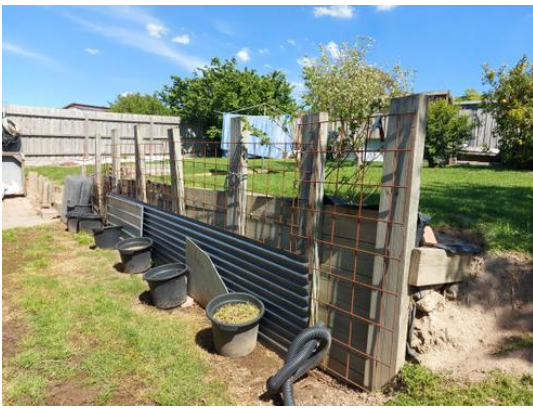
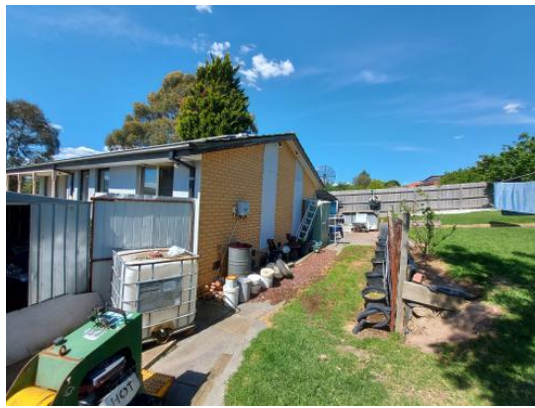
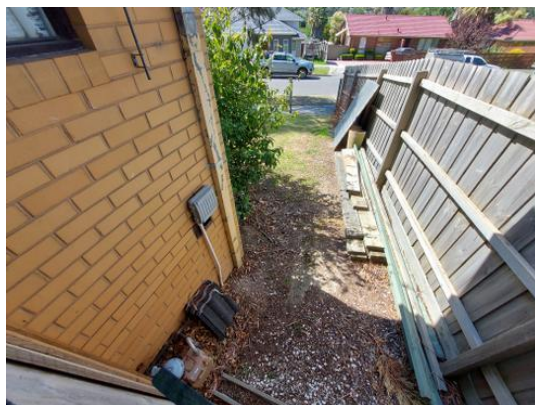
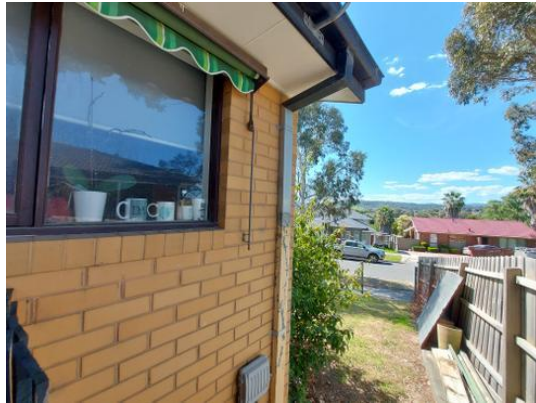
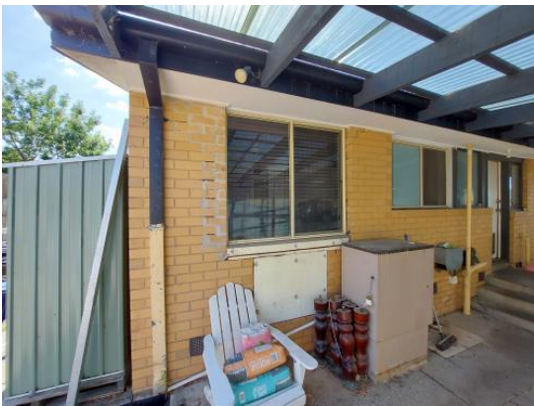
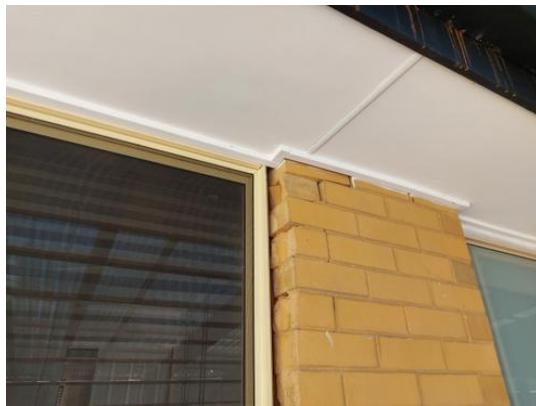
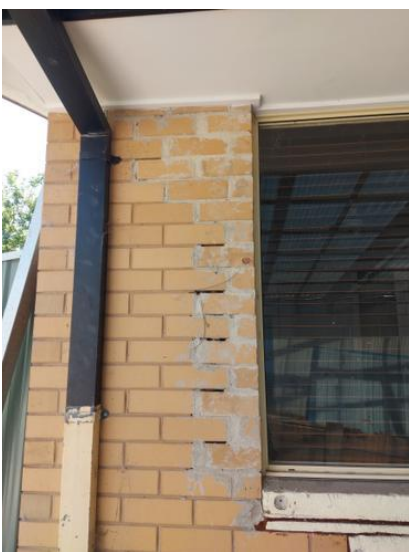
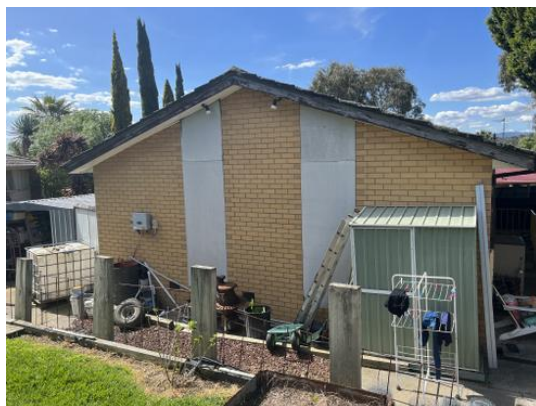
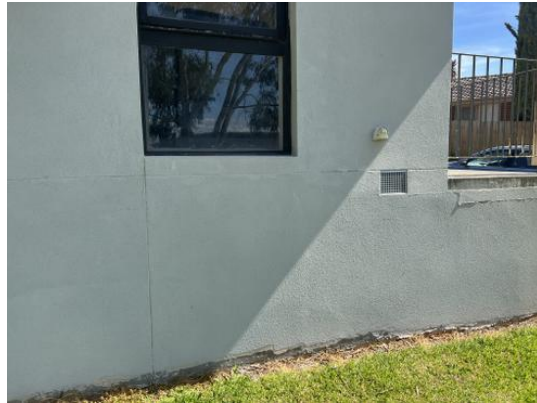
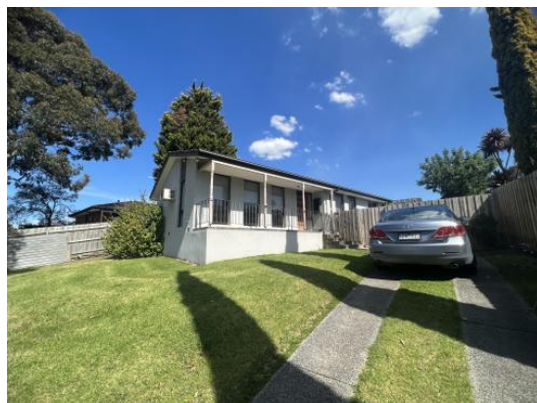
- The backyard slopes towards the rear of the dwelling.
- Site drainage around the property was generally poor, allowing water to flow into the subfloor during rainfall.
- Vertical and stepped cracking to the brickwork with signs of previous patching at the southeastern side of the dwelling (outside of 'Bedroom 3').
- Step cracking to brick cladding stemming from the top of the subfloor access door to the 'Laundry' window.

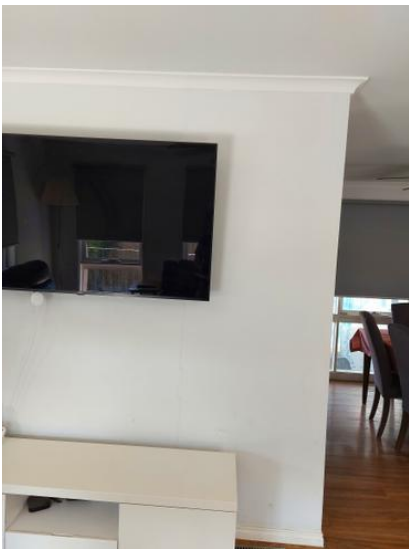
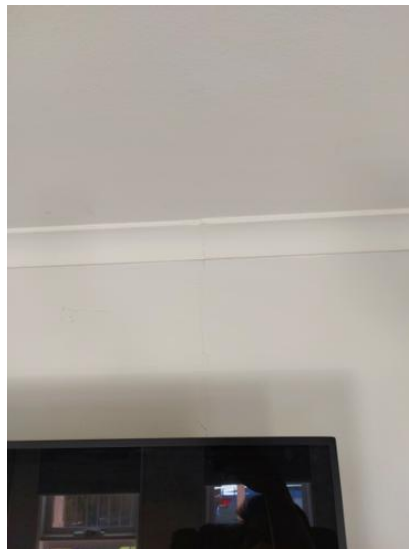
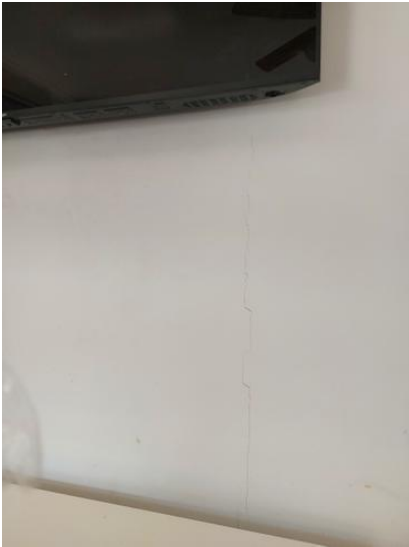
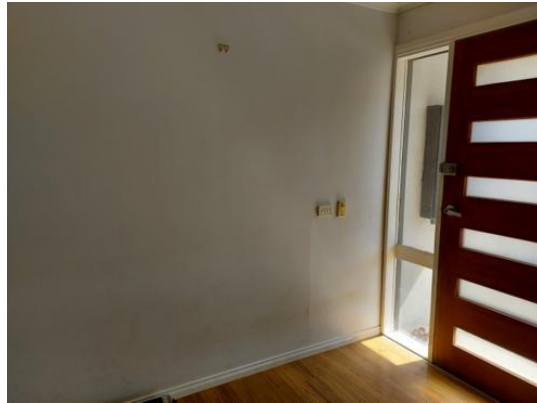
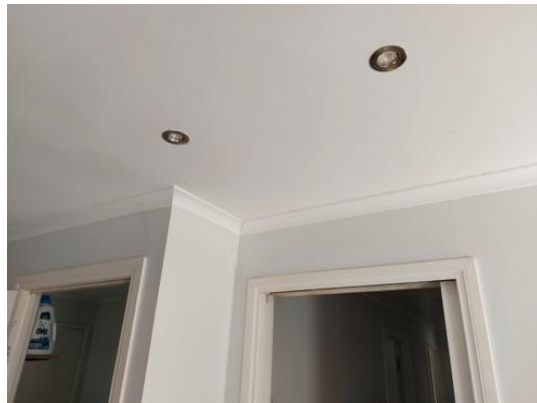
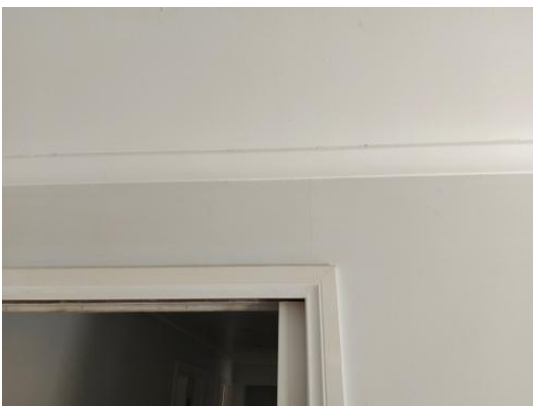
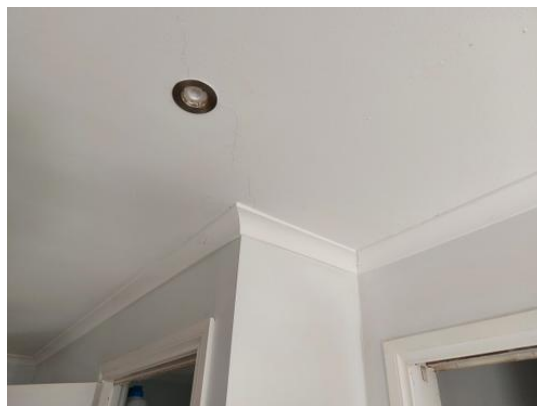
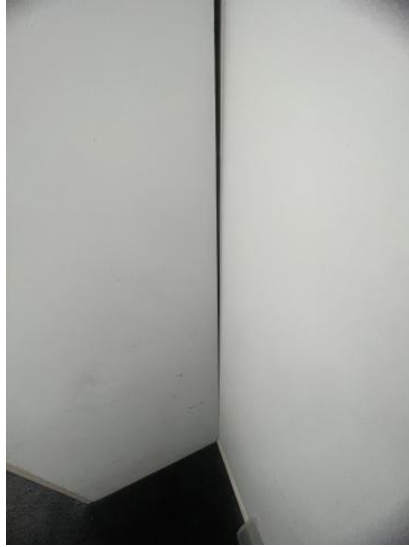
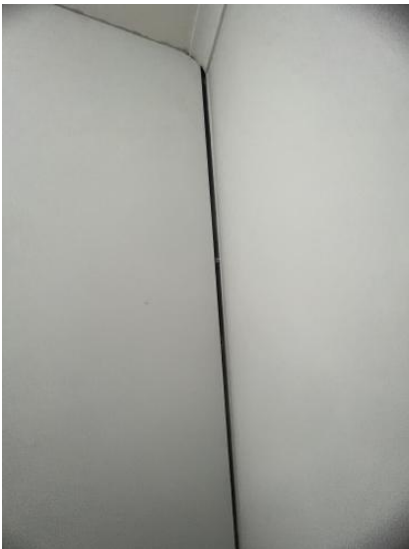
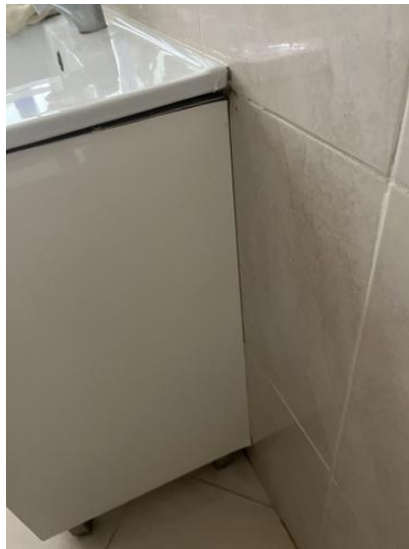
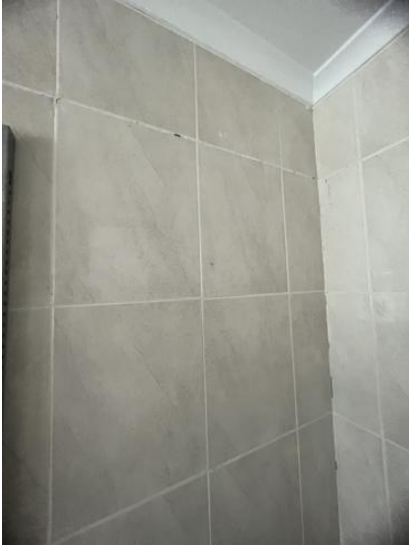
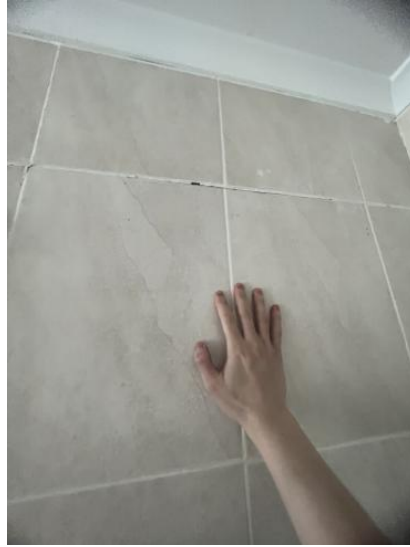
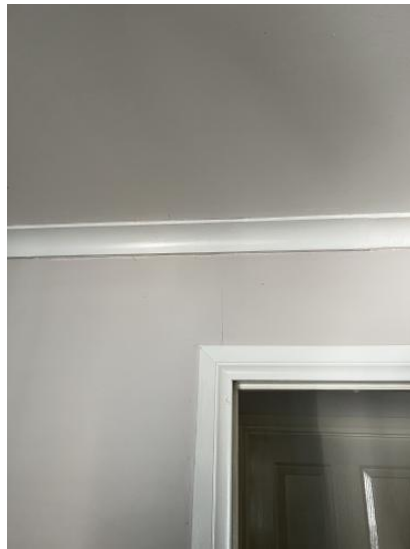
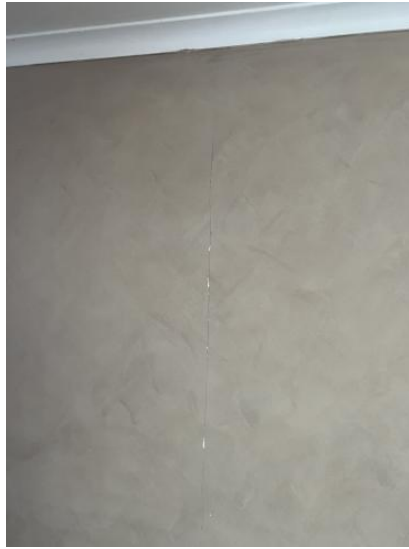
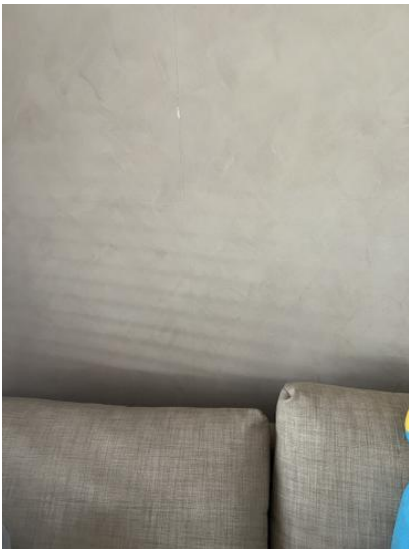
- Very slight-slight cracks to the walls and ceiling throughout the property.
- The wardrobe was observed to be leaning from the wall in Bedroom 2.
- Cracking to the bathroom area tiles was observed, which encourages moisture ingress into the underlying timber framing.
