SUPPLEMENTARY REPORT

Insured: James Dobbin
Loss Address: 16 Aaran Close, Endeavour Hills, VIC 3802
Claim Number: 6210287371
Client Reference: 1670192
CRD Reference: 1678899
Prepared By: Harry Giofkou
Date: 7 March 2022

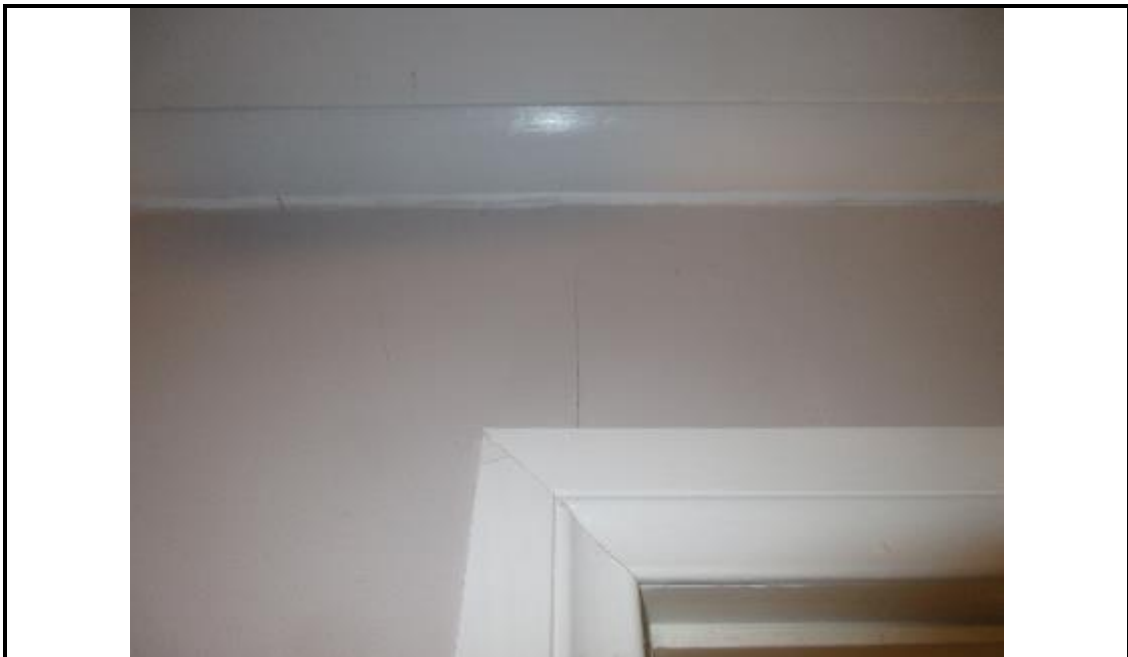
- 4.1 Internal inspection of the residence found the following:
- 4.1.1 Numerous hairline cracks to the wall linings and the mitre joints of ceiling cornices (Refer Appendix A – Photographic Supplement, Photos 2 & 3).

Photograph 2. Typical hairline crack to wall lining (in rear south-east bedroom).

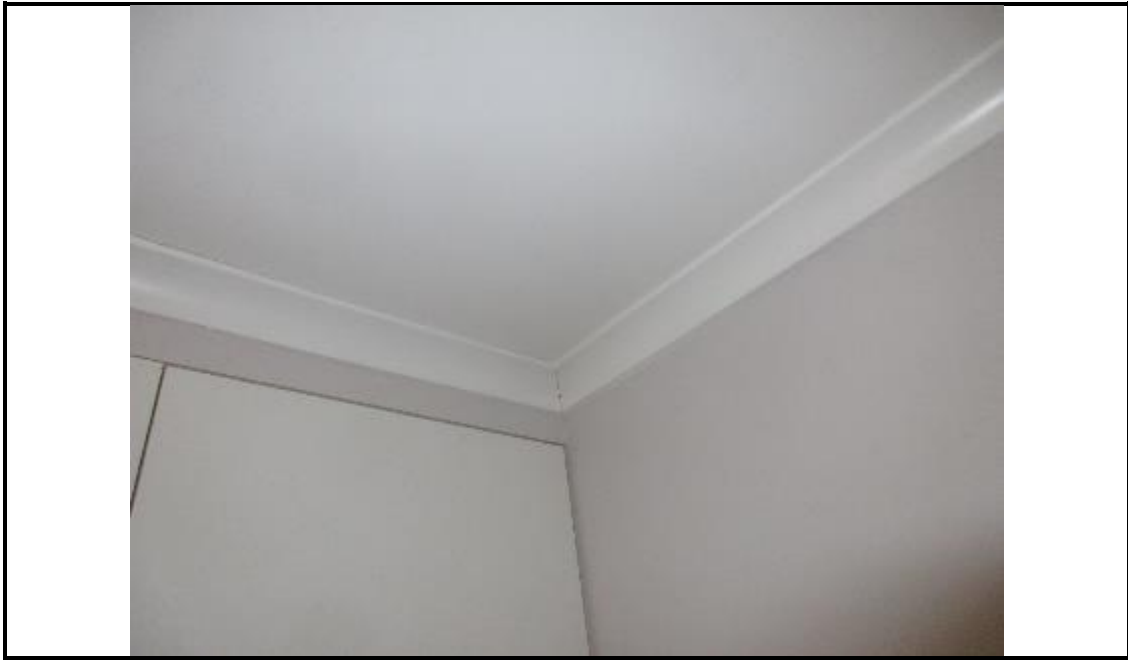
Photograph 3. Typical hairline crack to mitre joint of ceiling cornice.

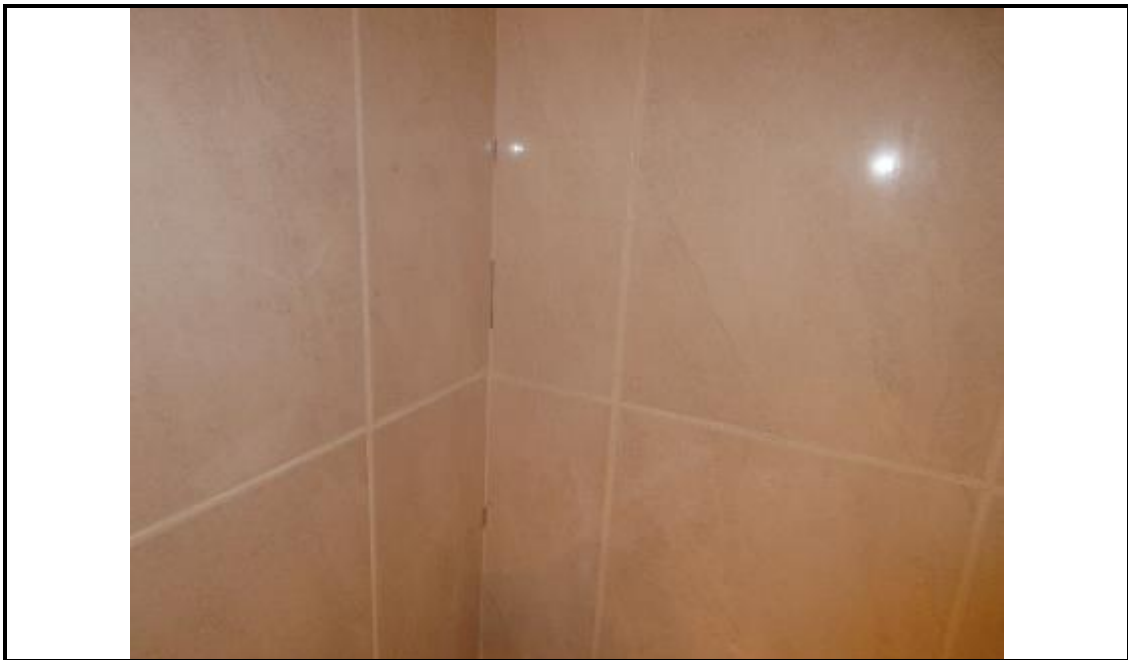
- 4.1.2 Cracking and deterioration to the grout of the wall tiles in the bathroom (Photo 4).
 - 4.1.3 Separation of the sides of the vanity unit from the underside of the bench top (Photos 5 & 6), with no similar movement at the floor / wall junction below the vanity unit (Photo 7). As there is no similar movement at the floor / wall junction, the separation at the sides / bench top junction is not related to footing movement.

Photograph 4. Damage to tile grout in bathroom.

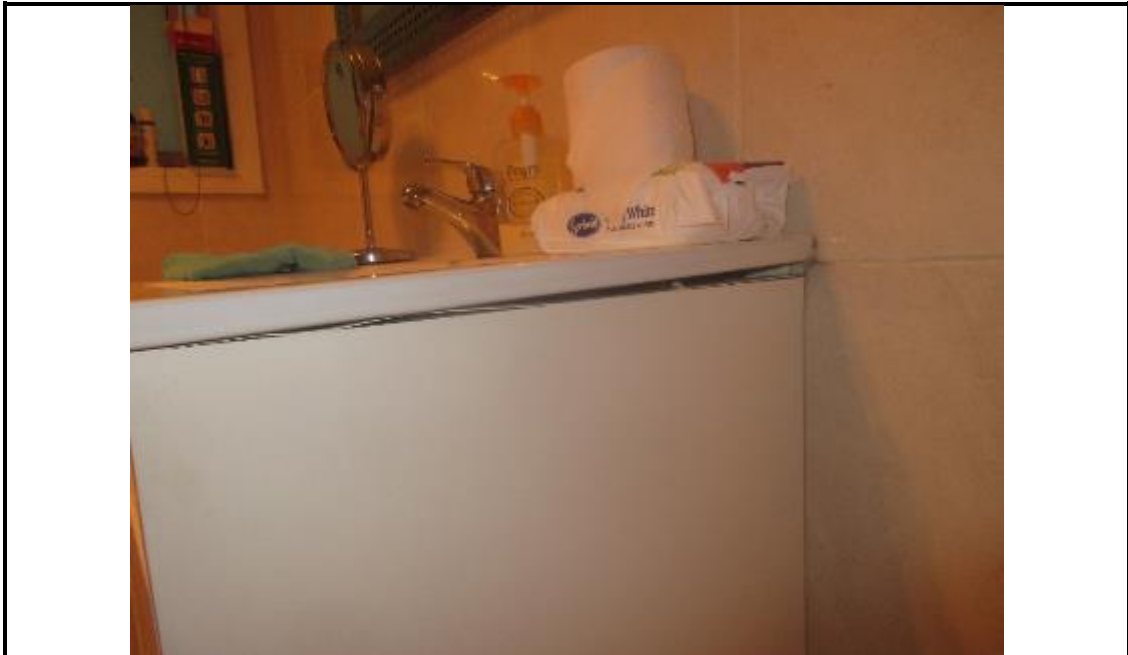
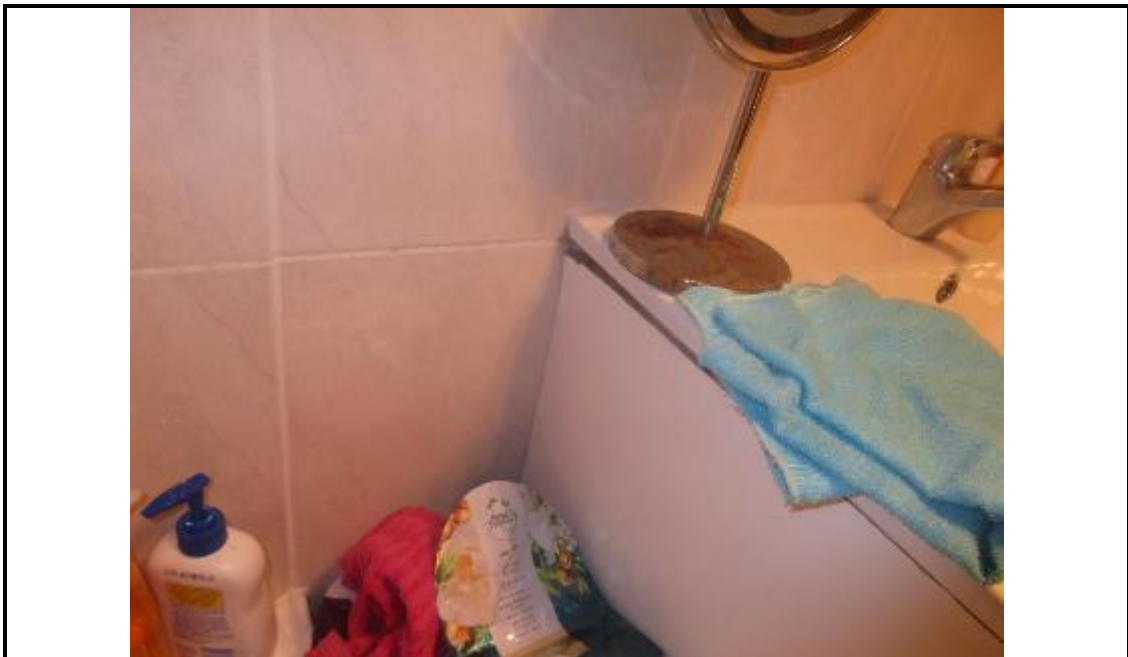
Photograph 5. Separation along vanity unit side / bench top junction.

Photograph 6. Separation along vanity unit side / bench top junction.

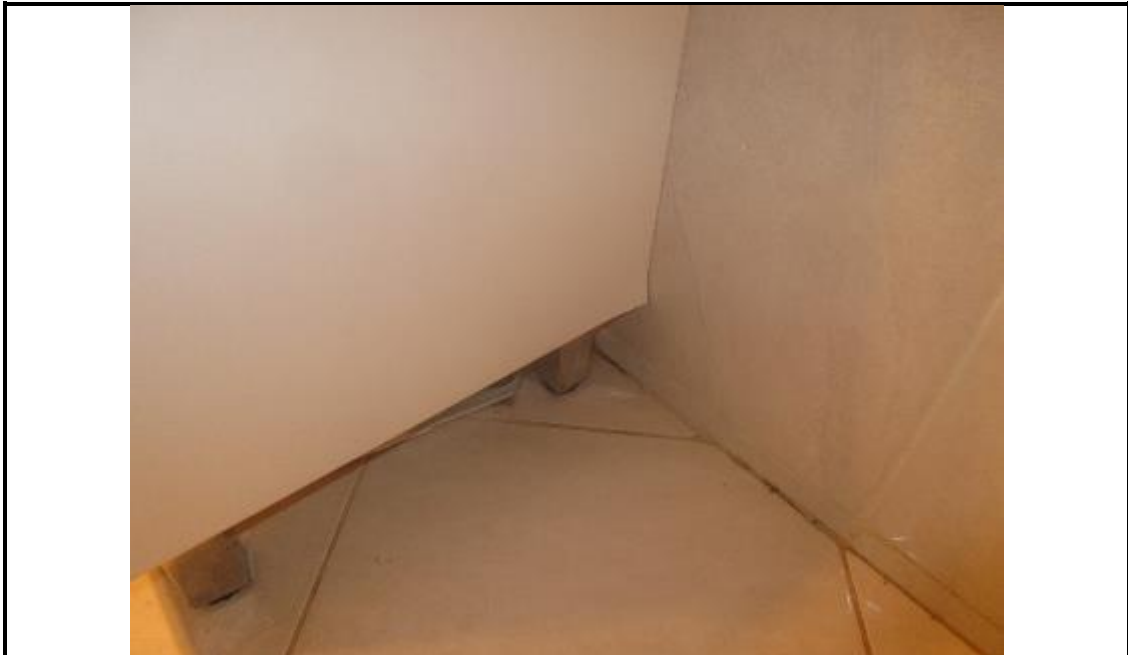
Photograph 7. No movement at floor / wall junction below vanity unit.

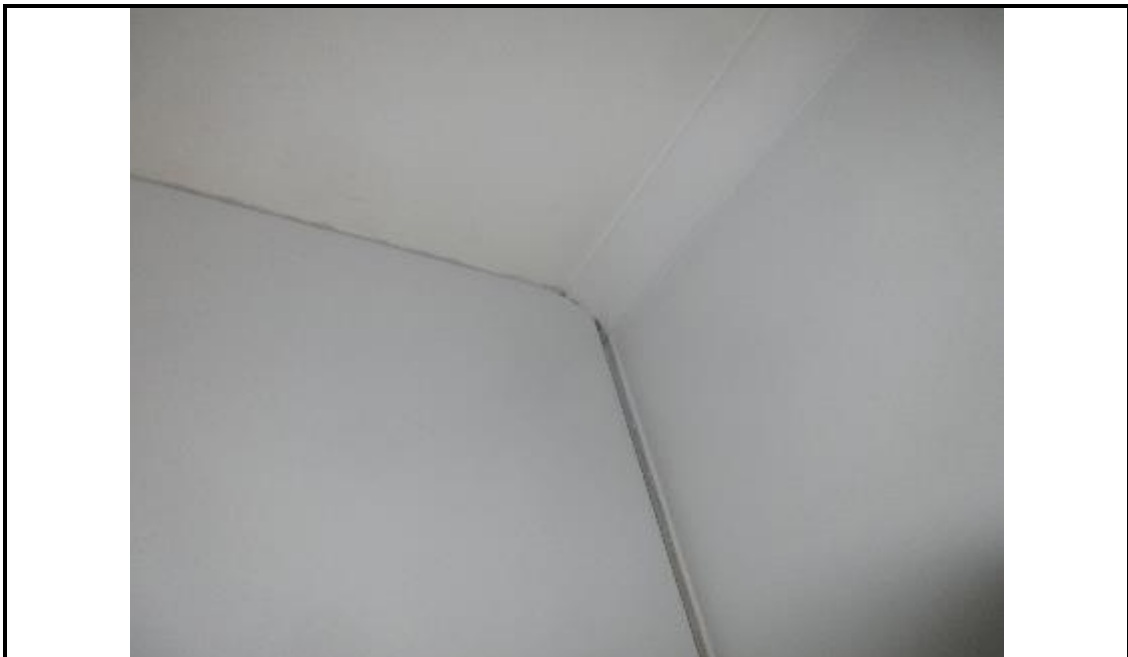
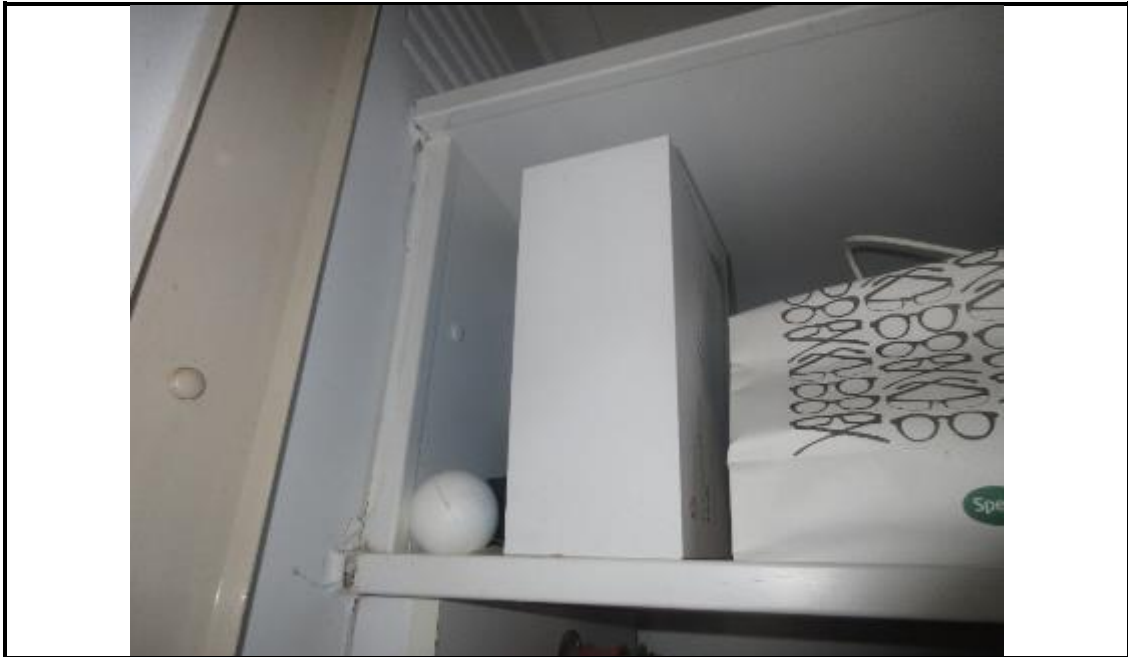
- 4.1.4 Separation of the bedroom 1 built in robes from the wall, as previously observed by our office at the time of the initial site inspection (Photos 8 & 9).

Photograph 8. Separation of bedroom 1 built in robes from the wall.

Photograph 9. Separation of bedroom 1 built in robes from the wall.

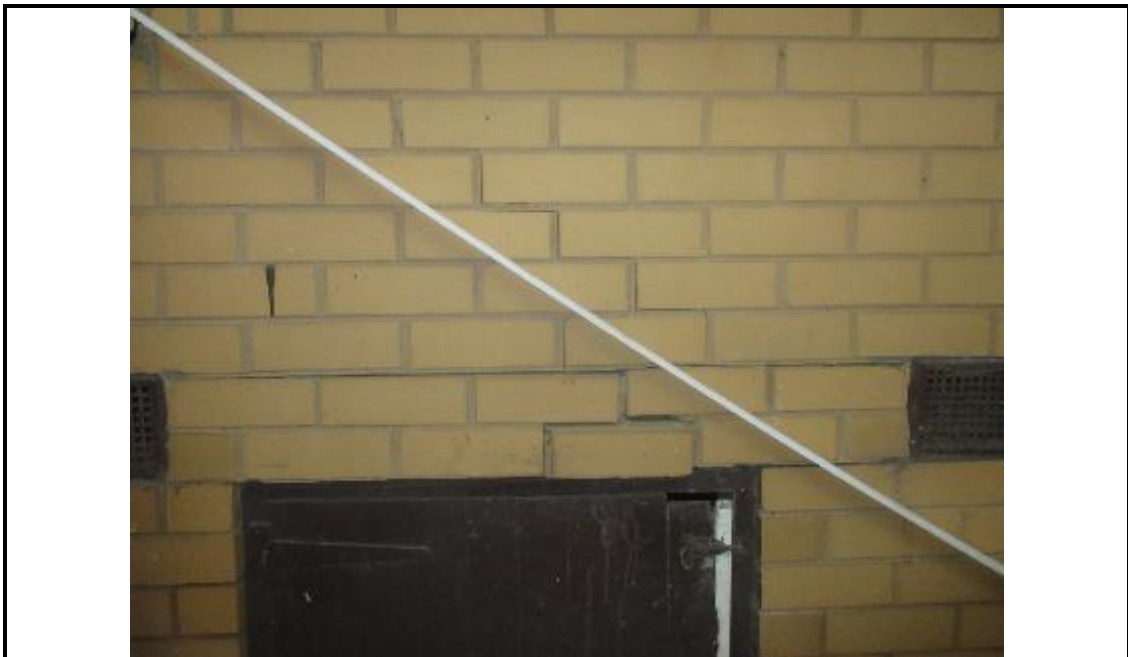
- 4.2 External inspection of the residence found the following:
- 4.2.1 Cracks to the brickwork along the east side elevation, the most severe above the sub-floor access door where a steel lintel has not been provided to support the brickwork (Photos 10 & 11), as previously observed by our office at the time of the initial site inspection.

Photograph 10. Crack above sub-floor access door, note no steel lintel above door to support brickwork.

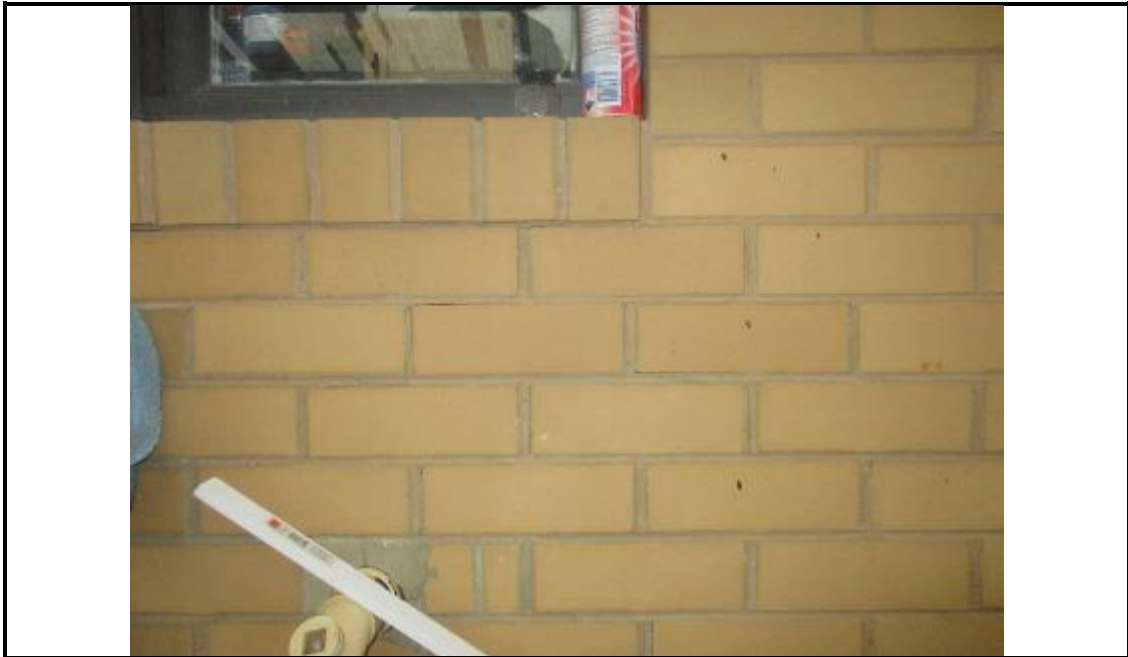
Photograph 11. Crack along east side elevation.

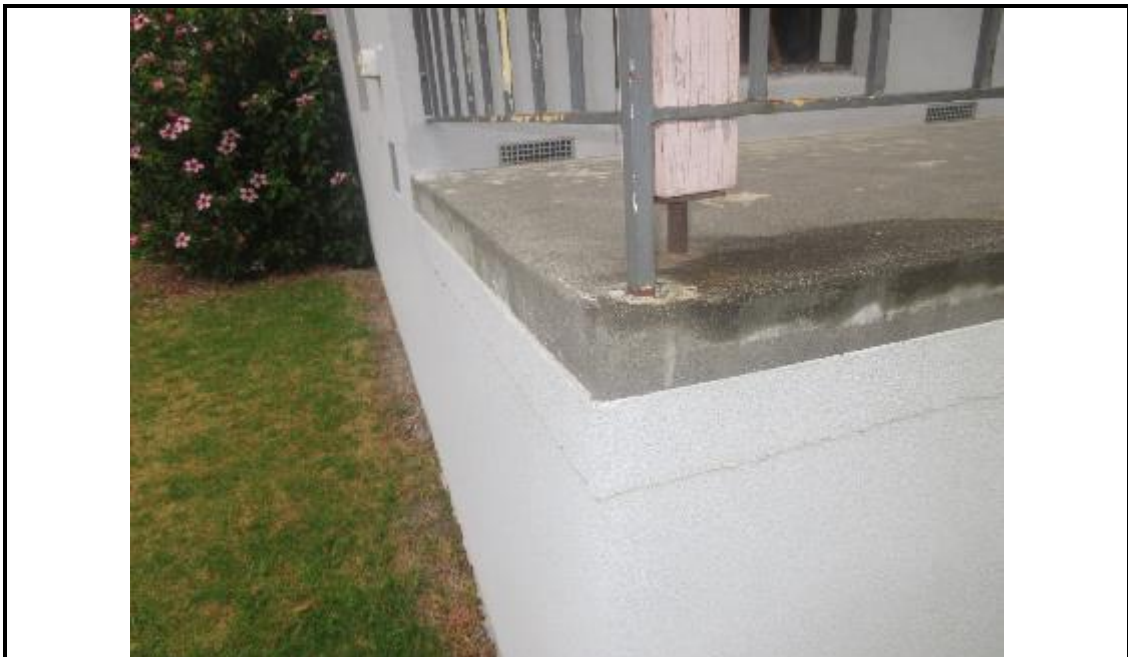
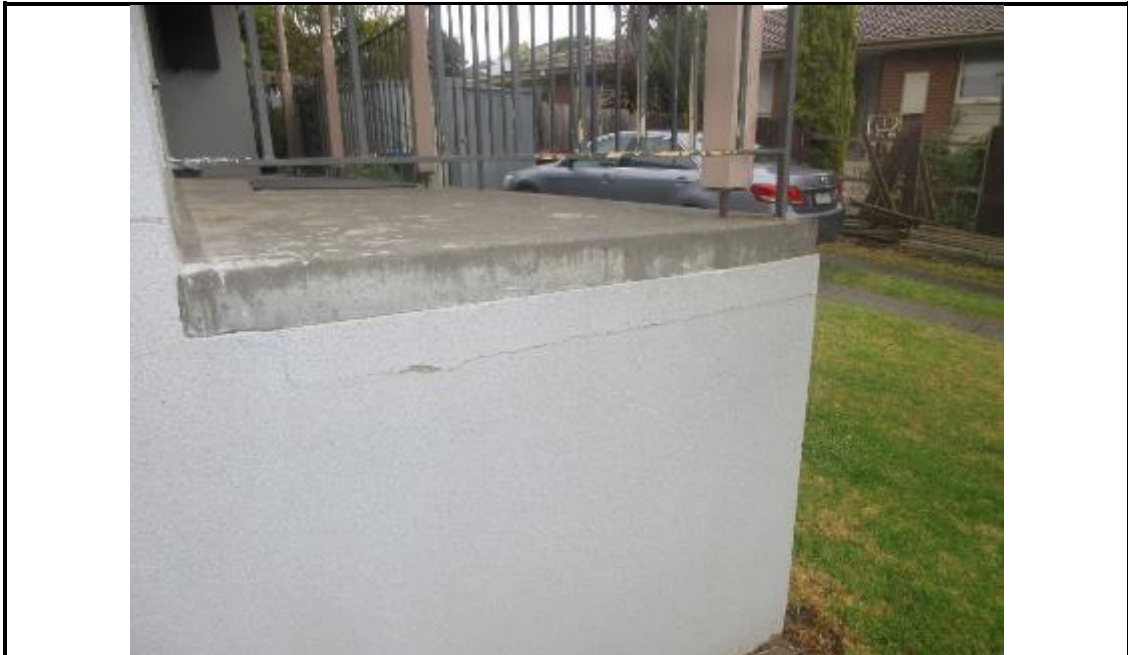
- 4.2.2 Cracks to the rendered brickwork below the porch slab at the north-west corner of the residence (Photos 12 & 13), as previously observed by our office at the time of the initial site inspection (Photos 14 & 15 – site visit 15 April 2020).

Photograph 12. Crack below porch slab.

Photograph 13. Crack below porch slab.

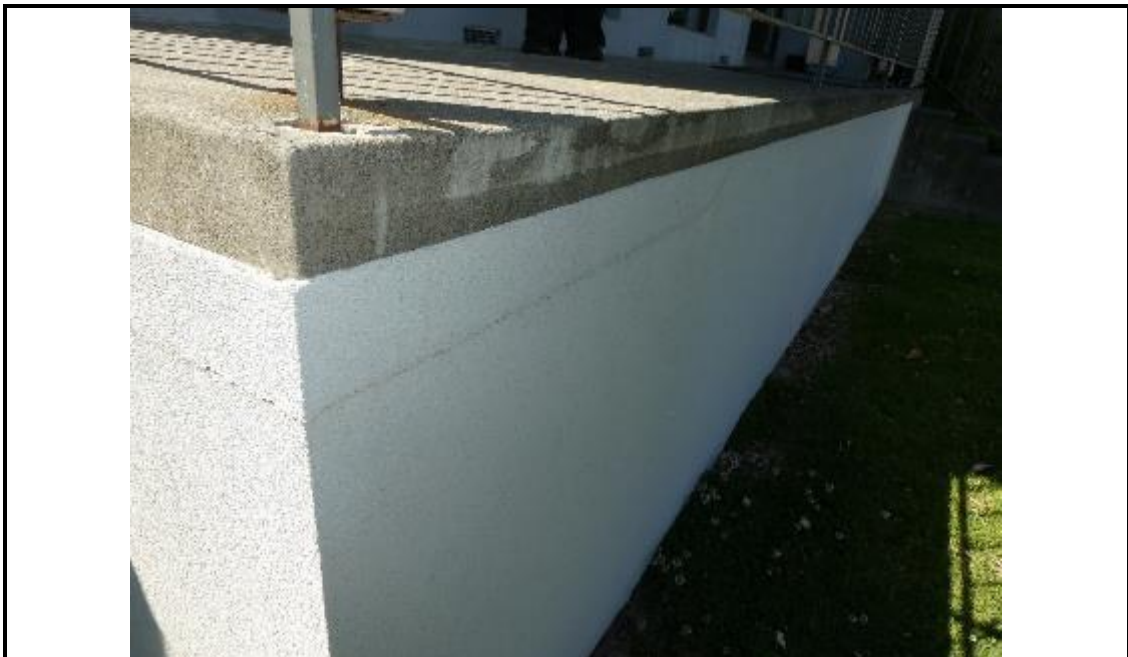
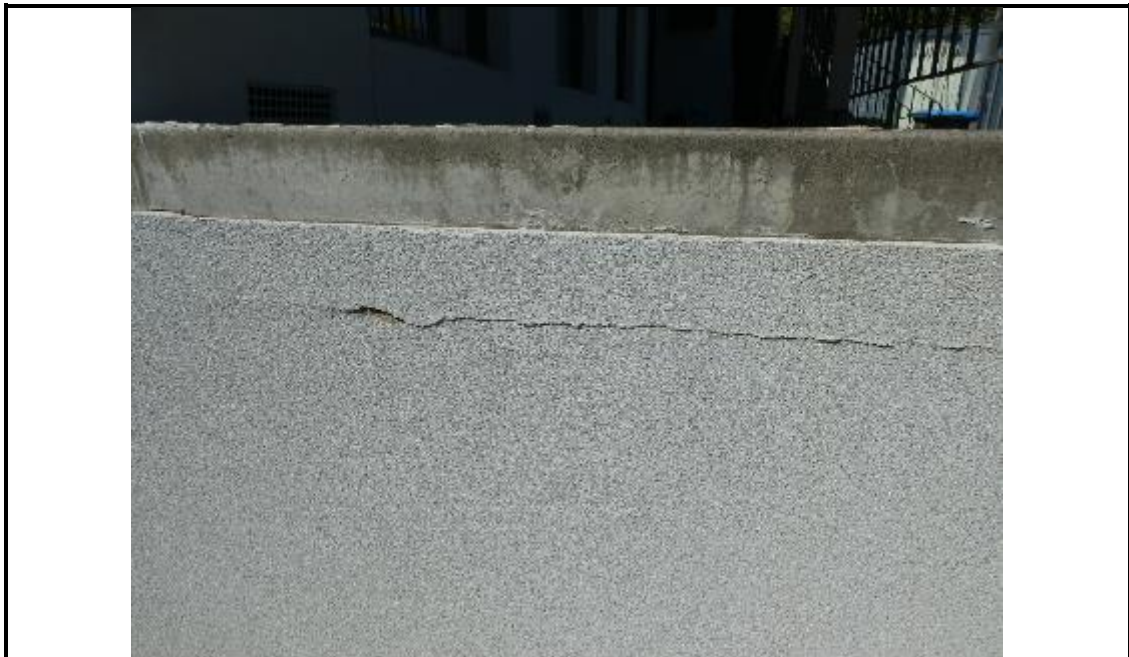
Photograph 14. Crack below porch slab (site visit 15 April 2020).

Photograph 15. Crack below porch slab (site visit 15 April 2020).

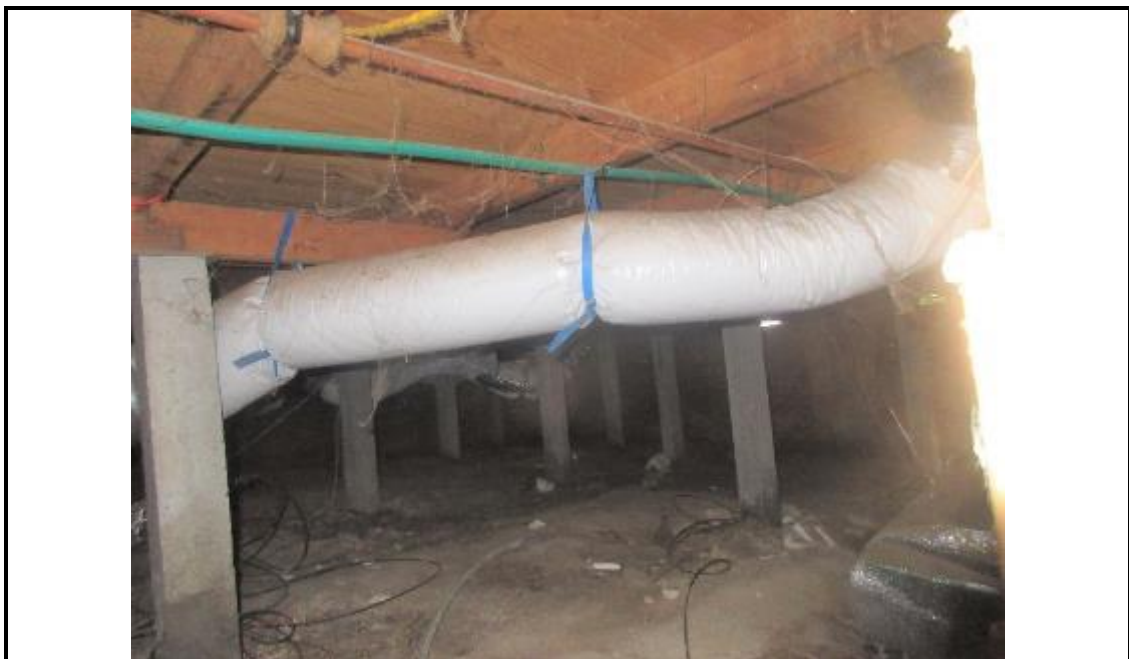
- 4.3 Inspection of the sub-floor space was only able to be carried out from the sub-floor access door which could not be fully opened due to being obstructed by the unit pavers. The limited inspection of the sub-floor space found no readily observed damage (Photo 16).

Photograph 16. View of sub-floor space.

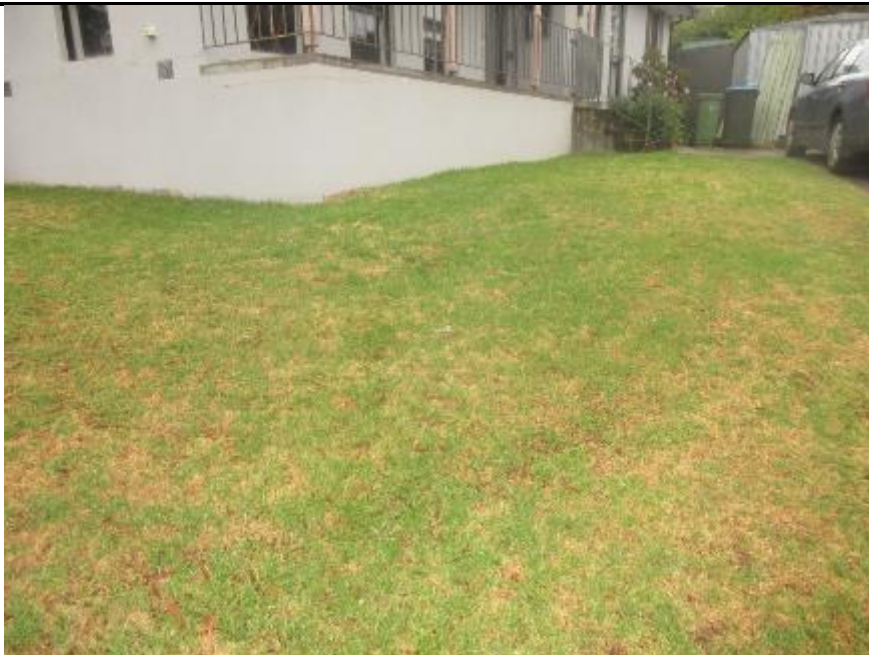
- 4.4 The location of the broken and leaking stormwater drain is downhill of the north-west corner of the residence (Photo 17). Therefore, water escaping from the broken and leaking drain would not drain to and concentrate adjacent the residence.

Photograph 17. Broken and leaking stormwater drain located downhill of north-west corner of residence.

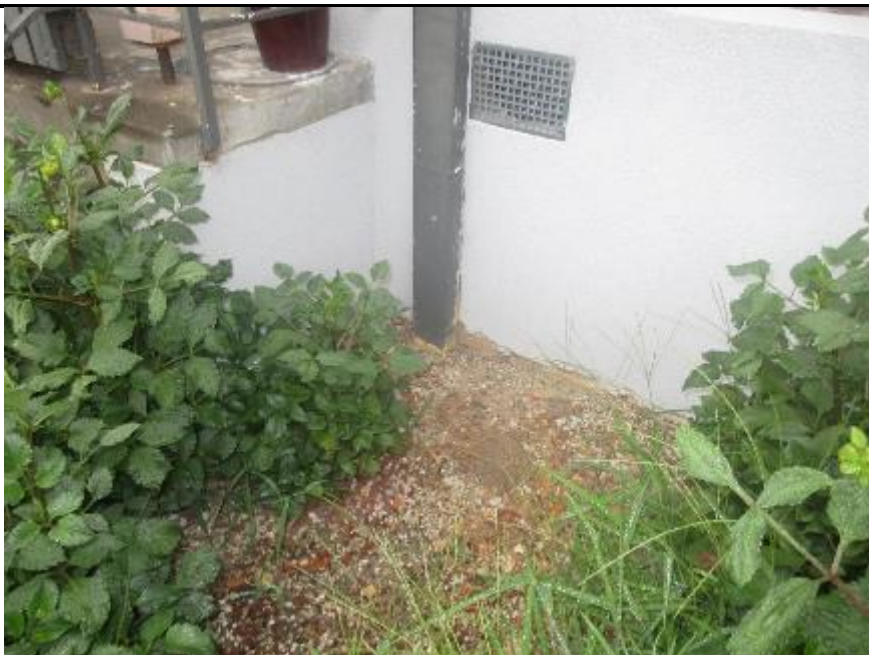
- 4.5 Inspection of the two downpipes closest to the broken and leaking stormwater drain found no evidence of water backing up and overflowing from the downpipes (Photos 18 & 19). This indicates that collected stormwater is not building up upstream of the broken and leaking stormwater drain and overflowing from the downpipes.

Photograph 18. Downpipe along west side elevation upstream of broken stormwater drain.

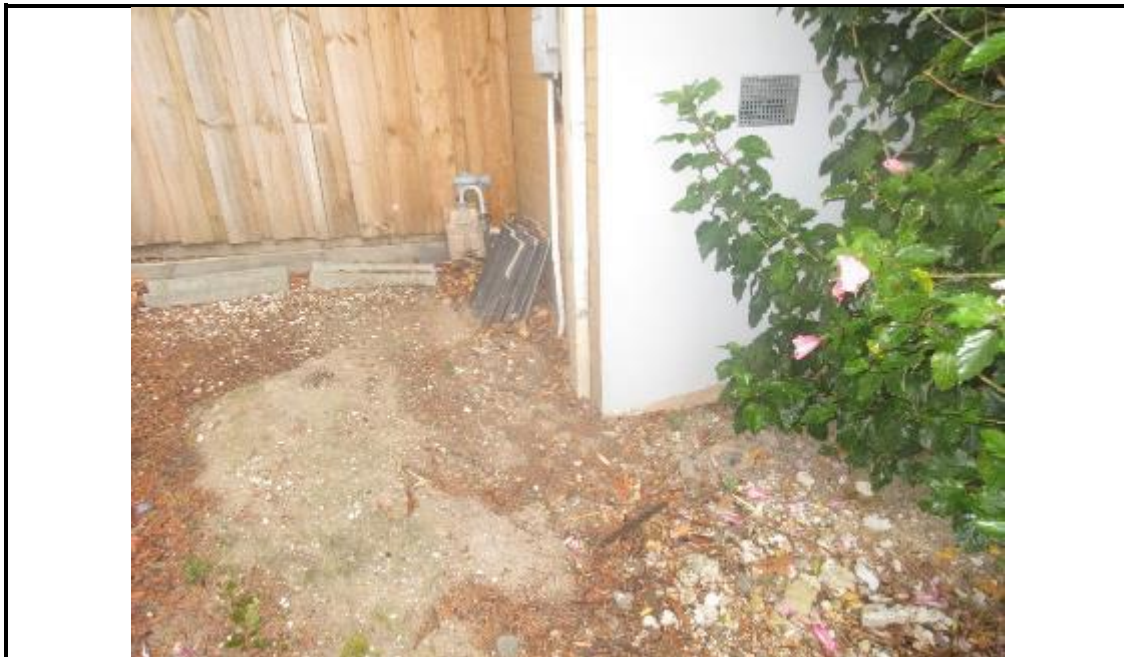
Photograph 19. Downpipe at north-east corner upstream of broken stormwater drain.

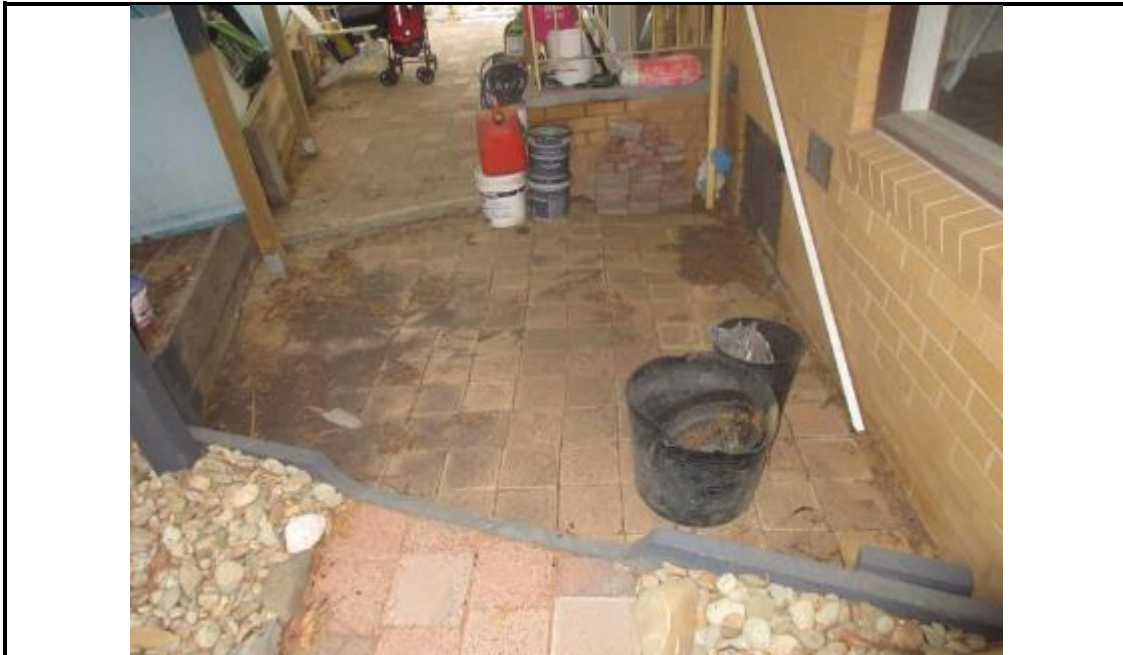
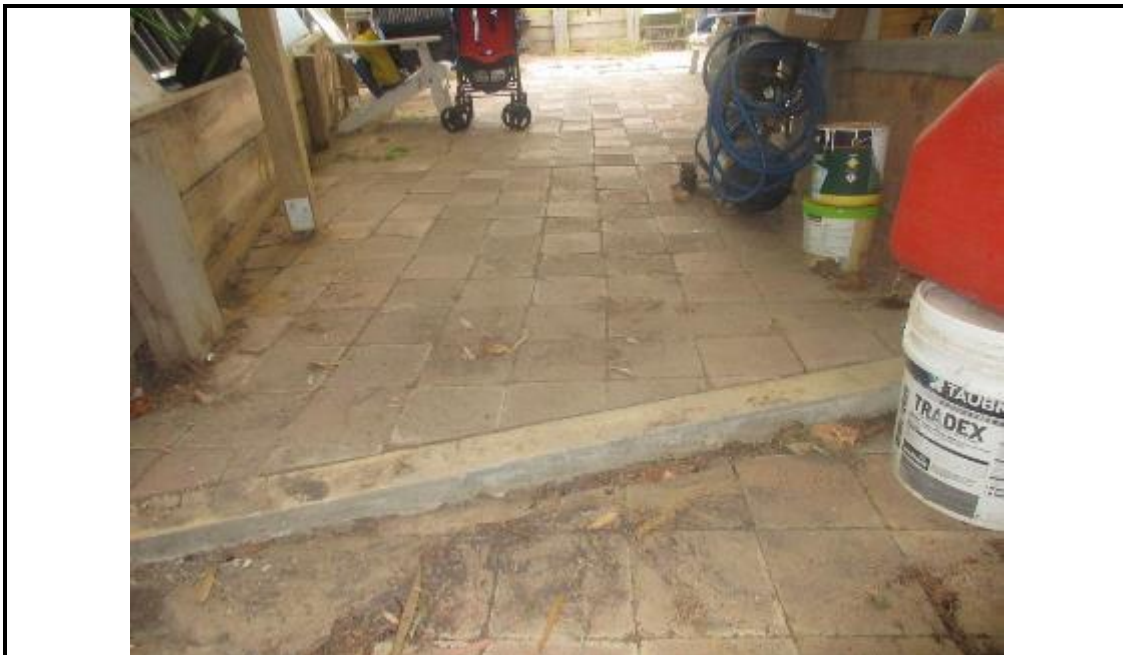
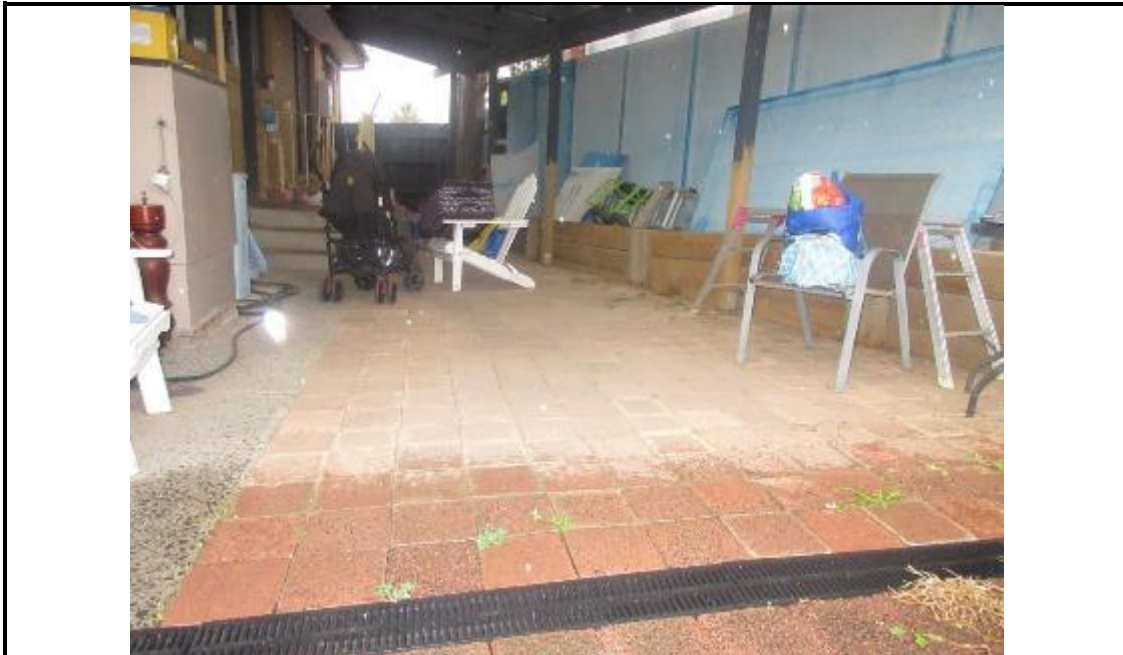
- 4.8.1 The Insured stated during the inspection that the unit pavers along the east side of the residence were removed and re-laid from adjacent the strip drain to the south, the timber retaining wall to the east and north, the concrete paving and adjacent the east side wall of the residence including at the sub-floor access door (refer Appendix B – Photos B1 – B3).

Photograph B1. View of unit pavers.

Photograph B2. View of unit pavers.

Photograph B3. View of unit pavers.

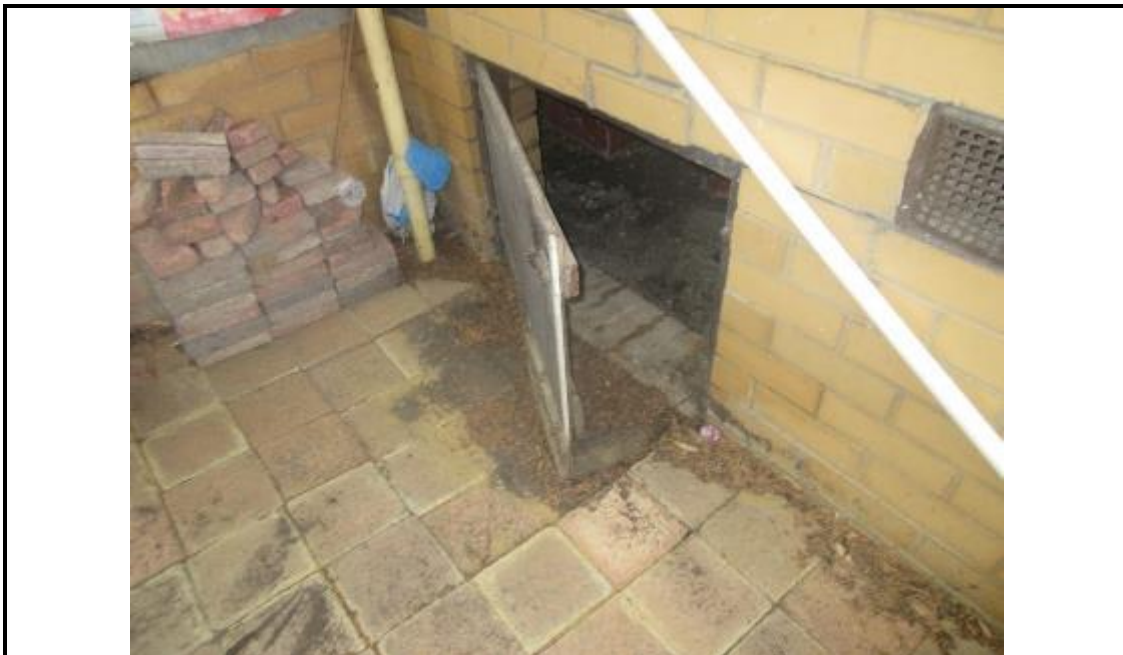
- 4.8.2 The Insured also stated that prior to the units pavers being removed and re-laid, the sub-floor access door could open fully, but now scrapes along the re-laid pavers preventing access to the sub-floor space (Photo B4).

Photograph B4. Sub-floor access door no longer opens fully.

- 6.1 The Insured consider undertaking works in order to improve adherence to the CSIRO – Guide to Foundation Maintenance and Footing Performance: A Homeowner’s Guide previously provided.
- 6.2 The responsible party should remove and re-lay the unit paving as per the scope of works, quote and invoice and to an acceptable standard.
- 6.3 The responsible party should remove and re-lay the verandah roof sheets on structurally adequate timber purlins and in accordance with manufacturer’s recommendations.

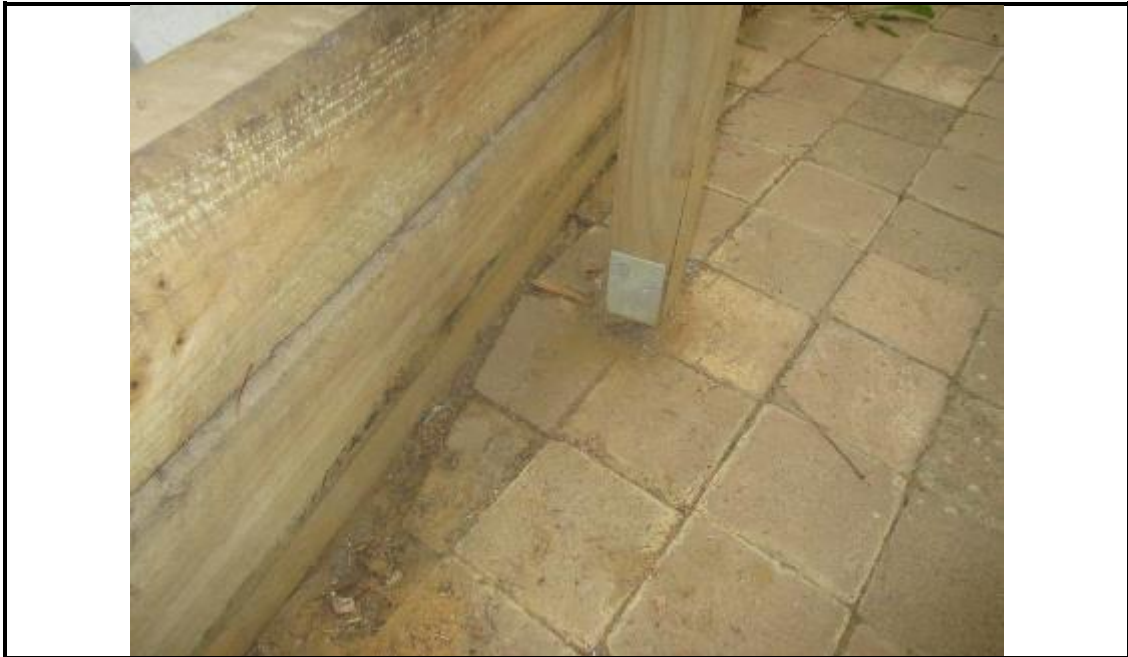
- 4.8.3 The Insured also stated that the pavers adjacent the retaining wall have been incorrectly re-laid with the edging mismatched (Photo B5).
- 4.8.4 Perusal of documentation on file found the following:

- 4.8.6 In the writer's opinion, the condition of the unit pavers is a result of poor workmanship. Unit pavers laid to an acceptable standard would not have undulations to the level across the surface, misaligned bedding joints and mismatched edging.

Photograph B5. Mismatched edging to unit pavers.

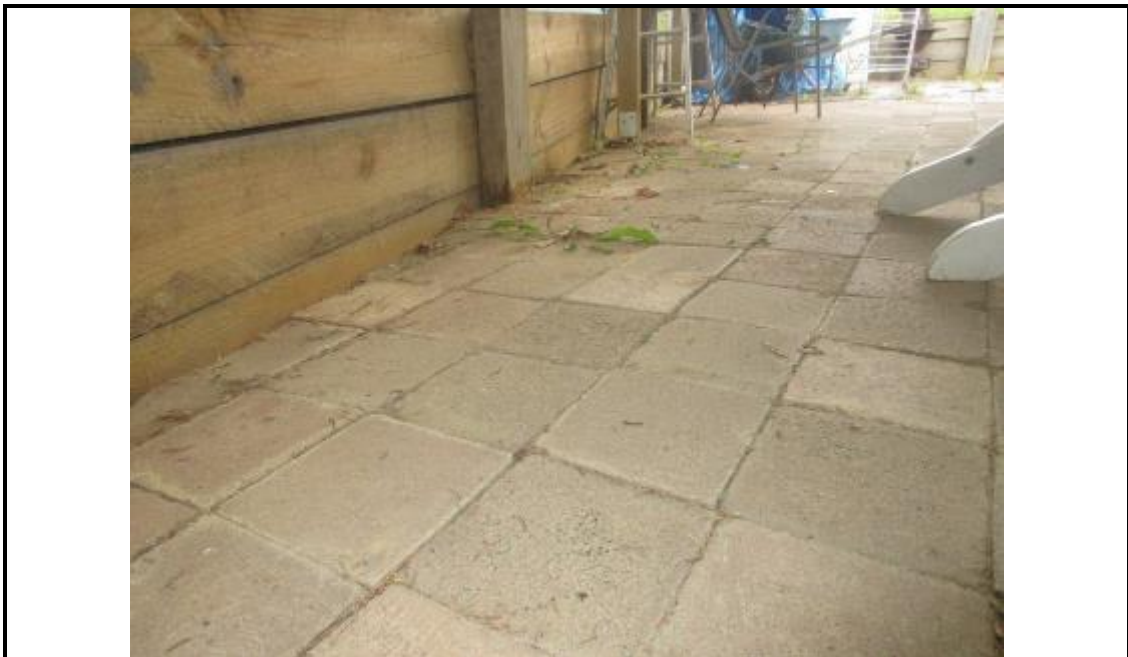
- 4.8.4.5 Invoice by Townsend Building Services dated 28 August 2020 for works completed as per the scope of works.
- 4.8.5 Inspection of the paved area found, in addition to 4.8.2 and 4.8.3 above, undulations to the level across the surface, and misaligned bedding joints (Photos B6 & B7).

Photograph B6. Undulating level across the surface of the paved area.

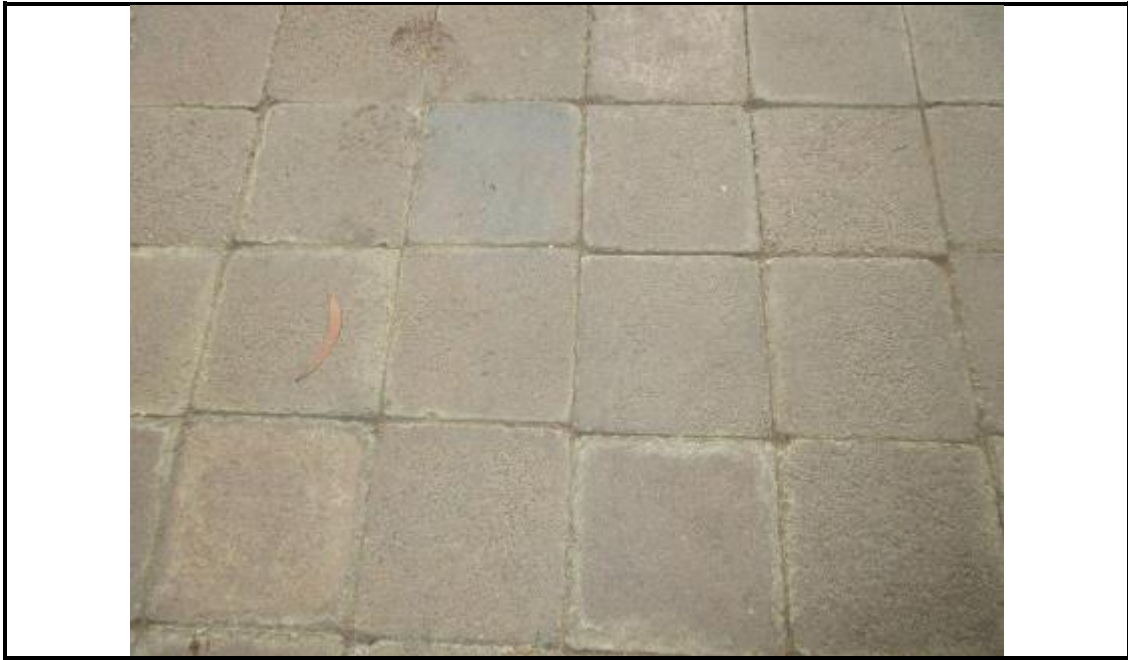
Photograph B7. Bedding joints misaligned.

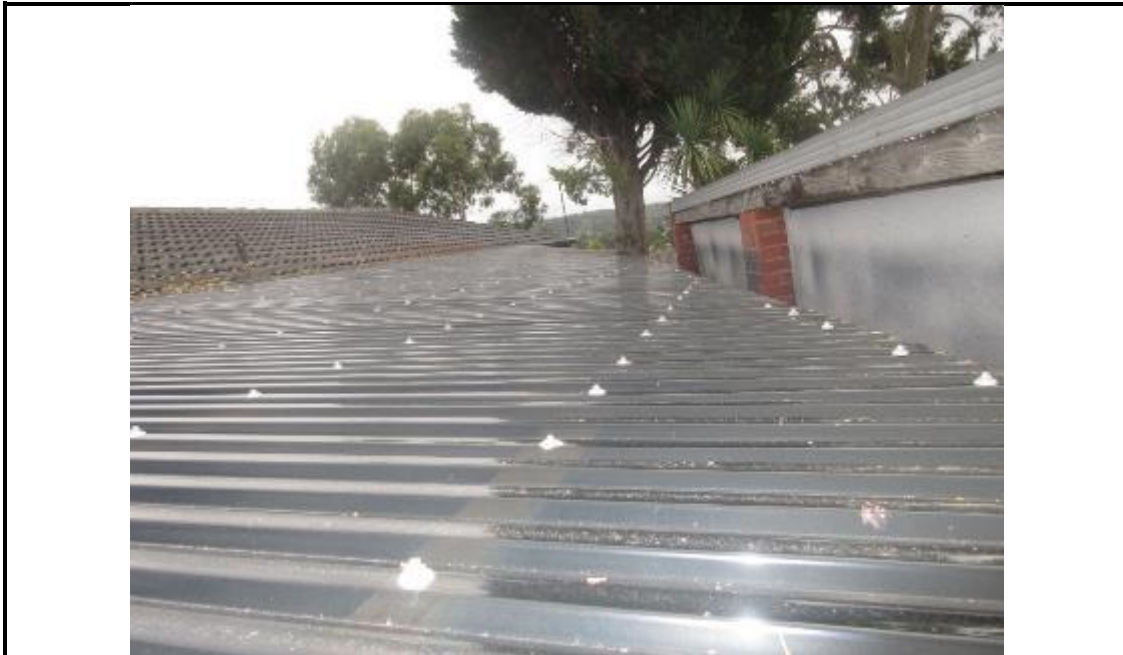
- 4.9.3 Inspection found that the roof sheets have been laid incorrectly with the side laps facing the prevailing wind direction (face south), not away from the prevailing wind direction (refer Appendix C – Verandah Roofing Photographic Supplement, Photos C1 & C2).

Photograph C1. View of verandah roofing.

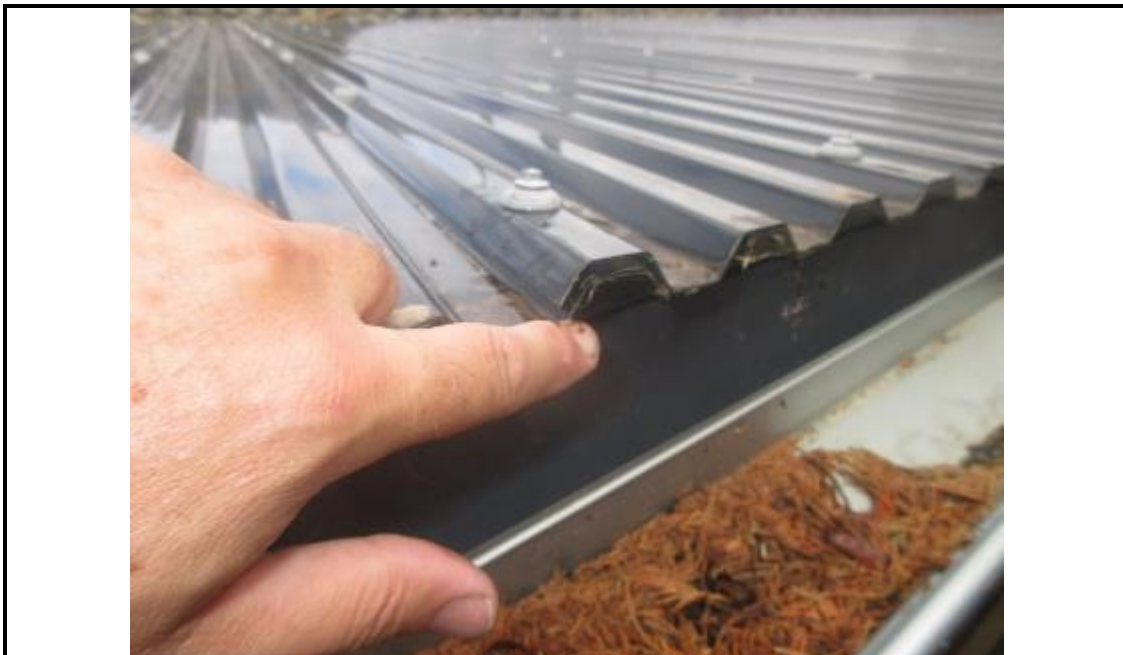
Photograph C2. Side laps facing south, i.e. into the prevailing weather.

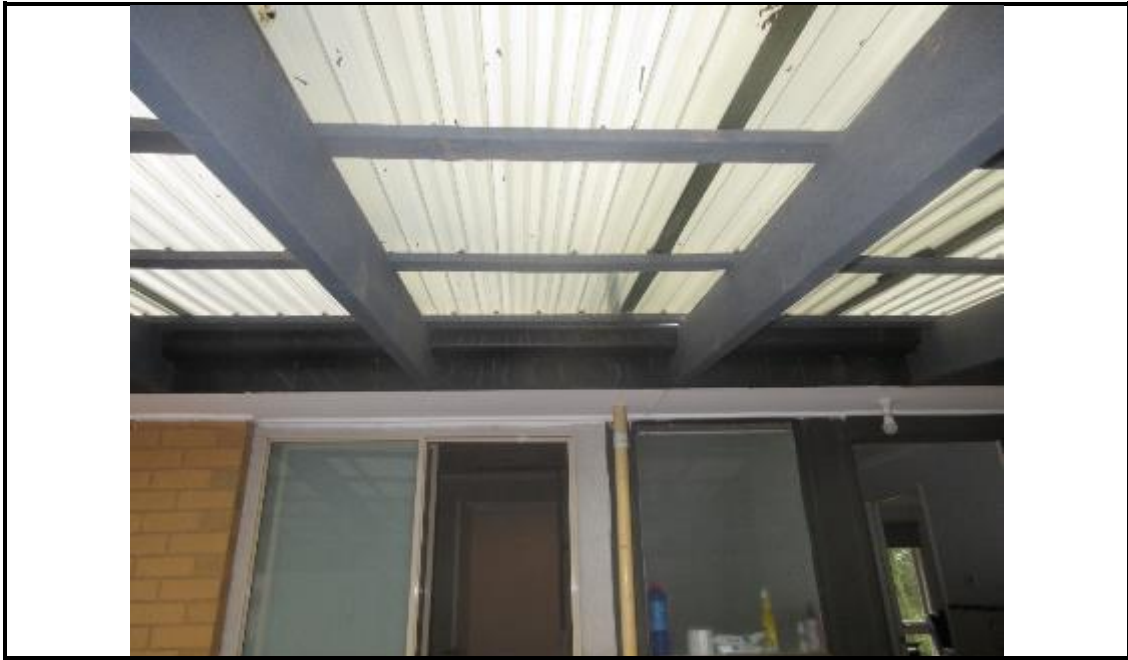
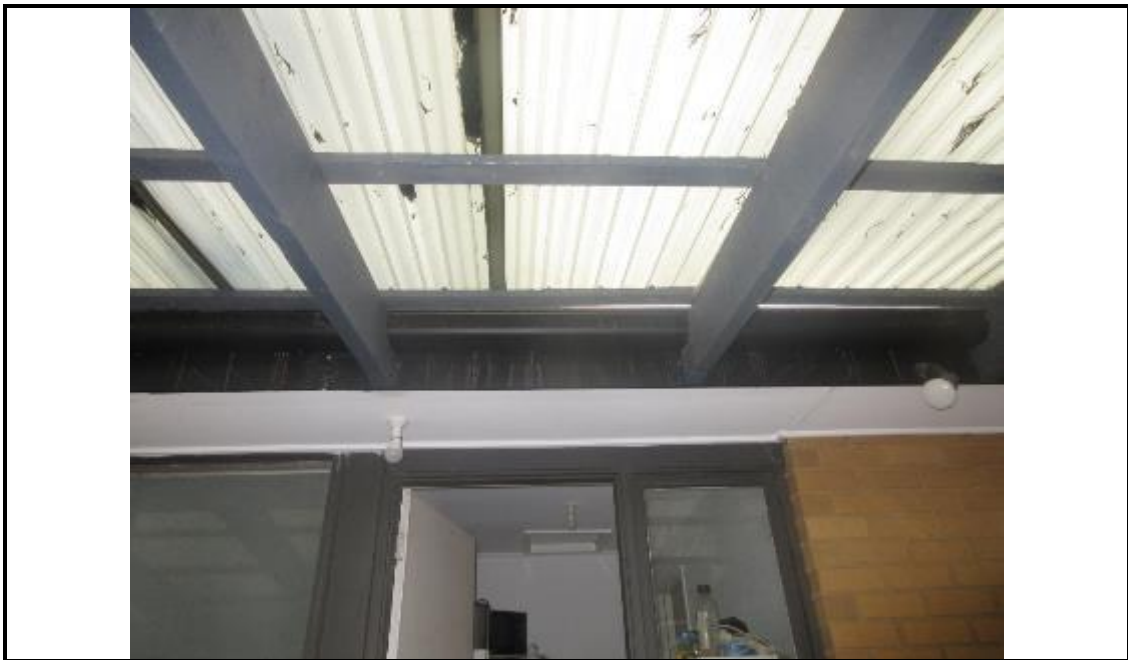
- 4.9.4 The timber purlins are sagging causing the roof sheets to sag (Photos C3 & C4). The timber purlins are 23 x 75 treated pine and the Insured stated they were supplied by the Insured and not by Townsend Building Services.

- 4.9.5 The timber purlins supplied by the Insured are undersized.

Photograph C3. Sagging to timber purlins.

Photograph C4. Sagging to timber purlins.
