SUPPLEMENTARY REPORT

Insured: James Dobbin
Loss Address: 16 Aaran Close, Endeavour Hills, VIC 3802
Claim Number: 6210287371
Client Reference: 1670192
CRD Reference: 1678899
Prepared By: Harry Giofkou
Date: 7 March 2022

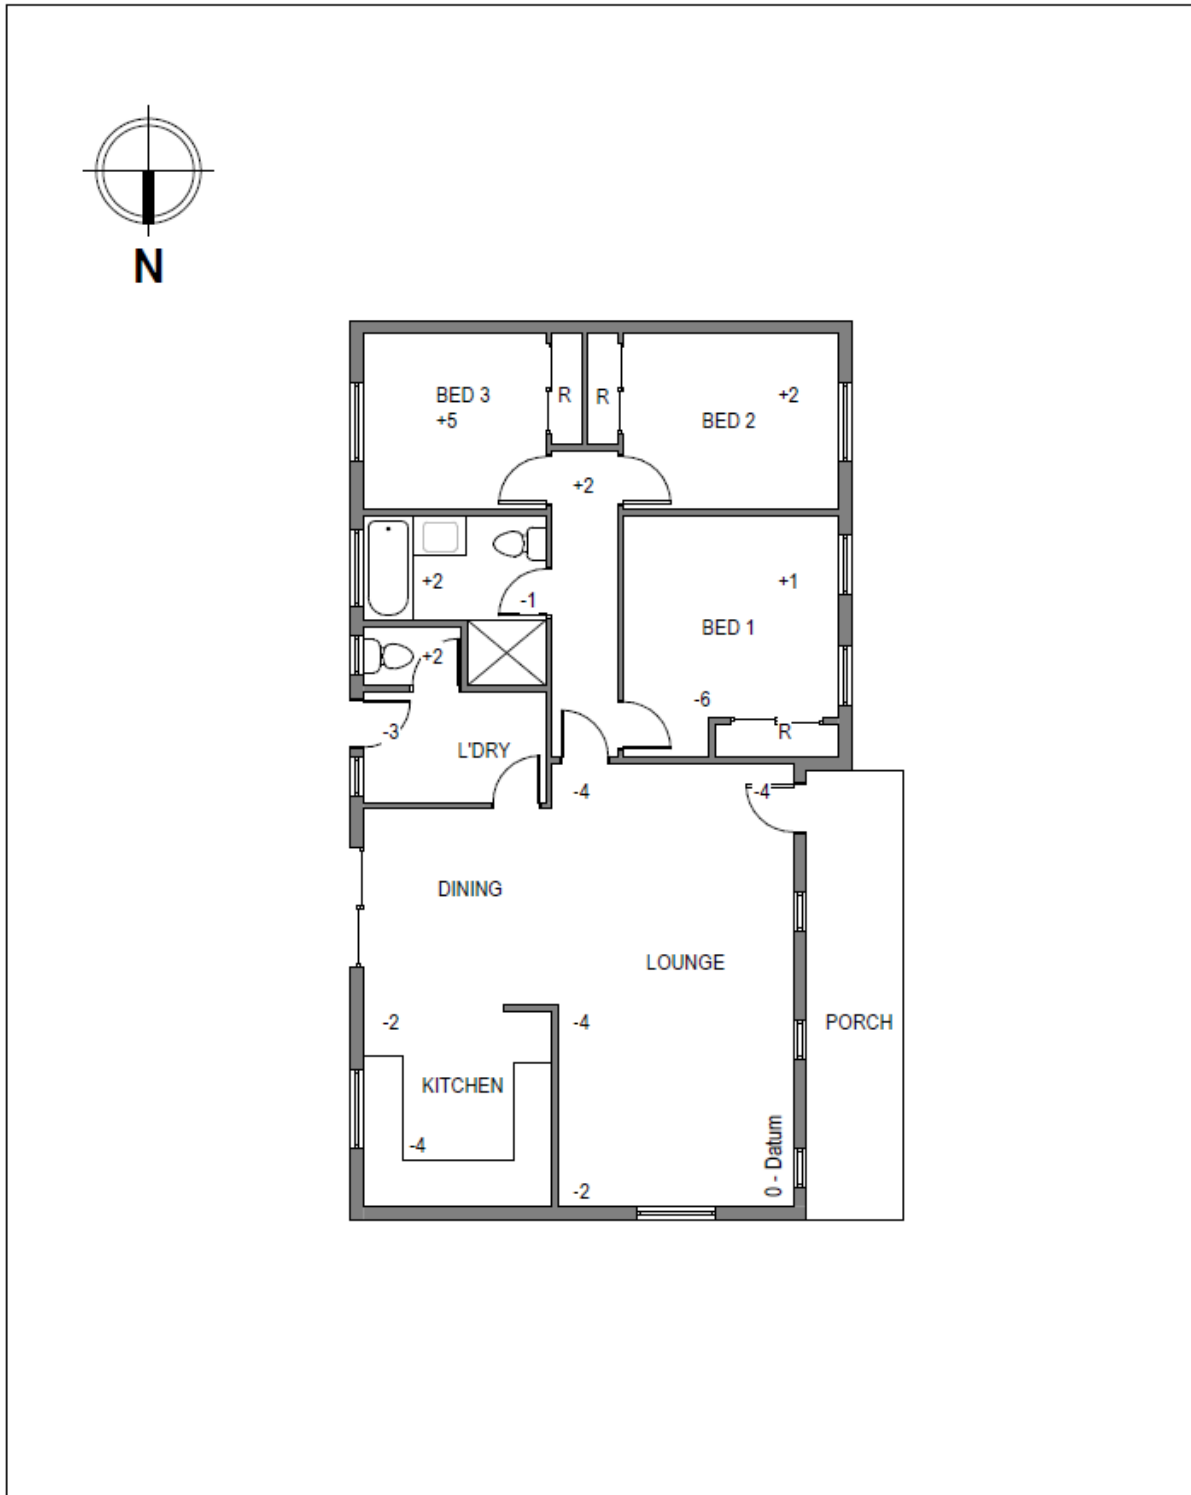
- 4.7.1 A floor level survey was carried out and the results are shown in Appendix D – Floor Level Survey.
- 4.7.2 The floor level survey found the floor is relatively level and does not indicate movement related to the flooding in February 2020 or the broken and leaking stormwater drain at the north-west corner of the property.
