Roof Report

Property Address	16 Aaran Close Endeavour Hills VIC 3802
Brand	Allianz Australia Insurance Limited
Claim No.	6210287371

Builder	Ambrose Construct Group Pty Ltd
Ambrose Job - PO No.	20067240

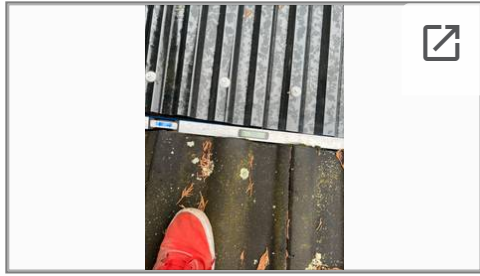
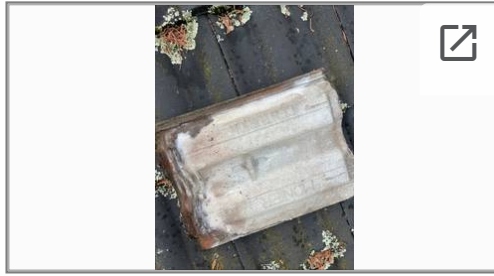
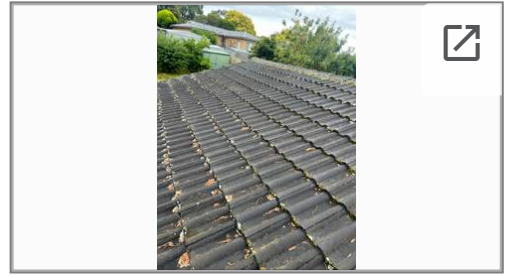
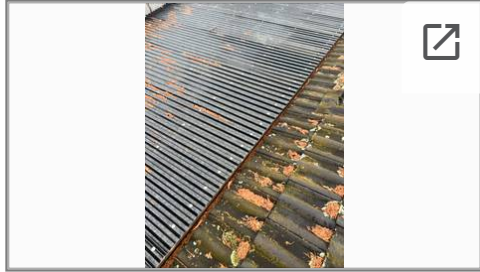
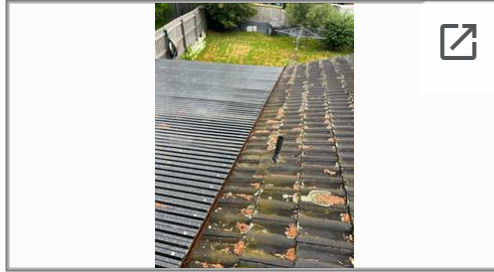
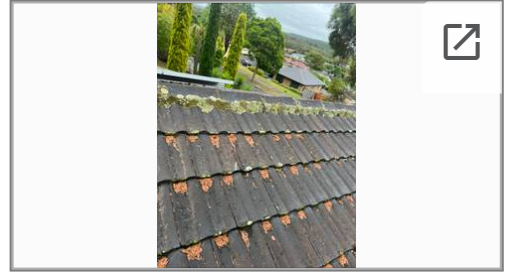
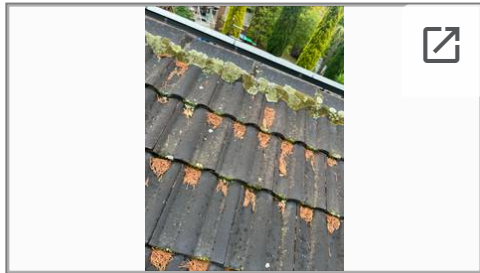
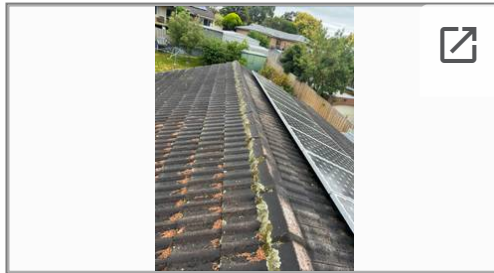
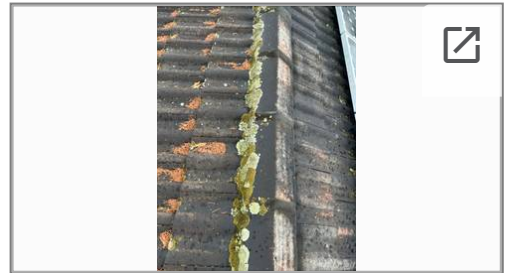
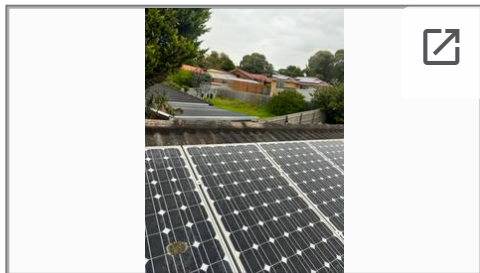
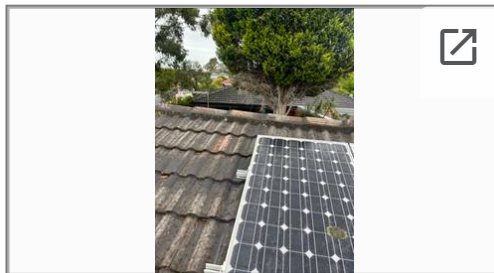
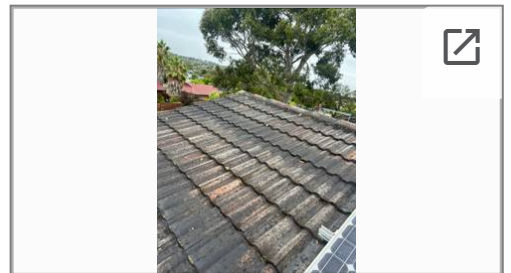
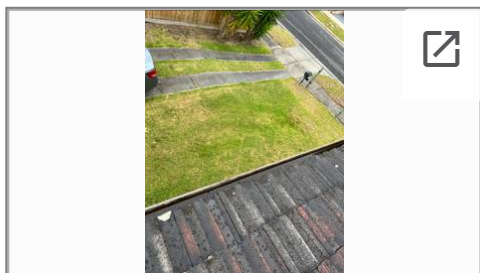
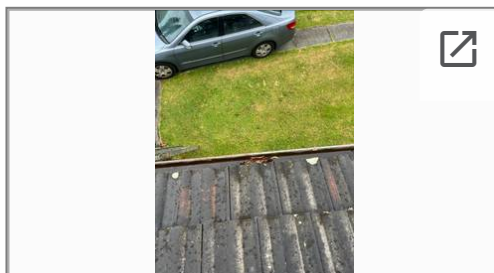
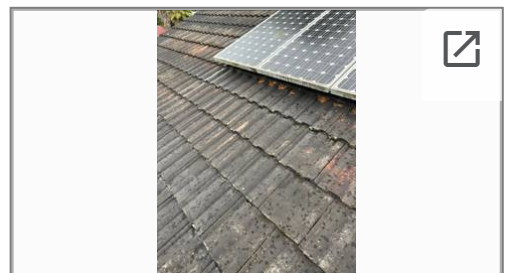
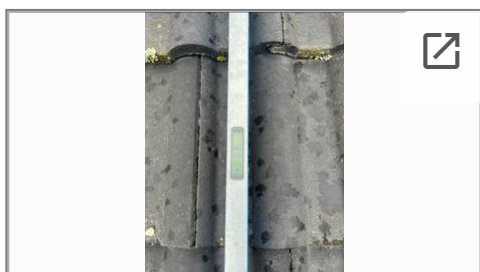
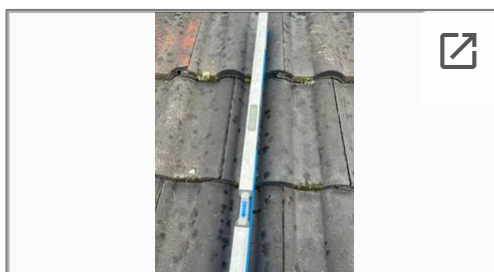
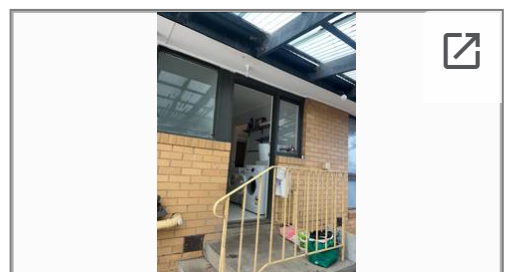
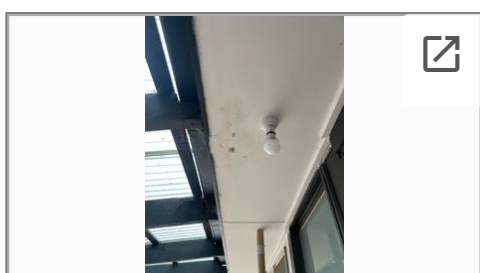
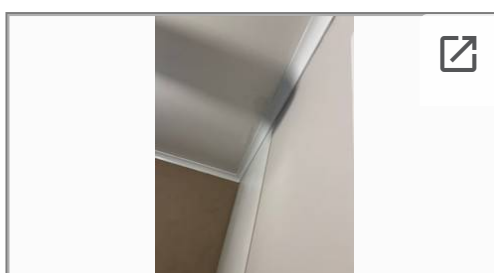
With the evidence provided at the time of the assessment the team identified that the back of the tiles have water stains all on them as there is no sarking and the roof is under pitched, gutter has no fall and has debris built up in them there are no weep holes in the mortar of the top ridge

The team identified surface rust to the gutters under debris, extent of rust is unknown

Roof plumber scope:
-replace gutters
